**Virginia Department of Transportation
X Lite Tangent 50' (15.24 m) System**

**Virginia Department of Transportation
1401 E. Broad St.
Richmond, VA 23219**

TR-P36131-01-NC

September 20, 2016

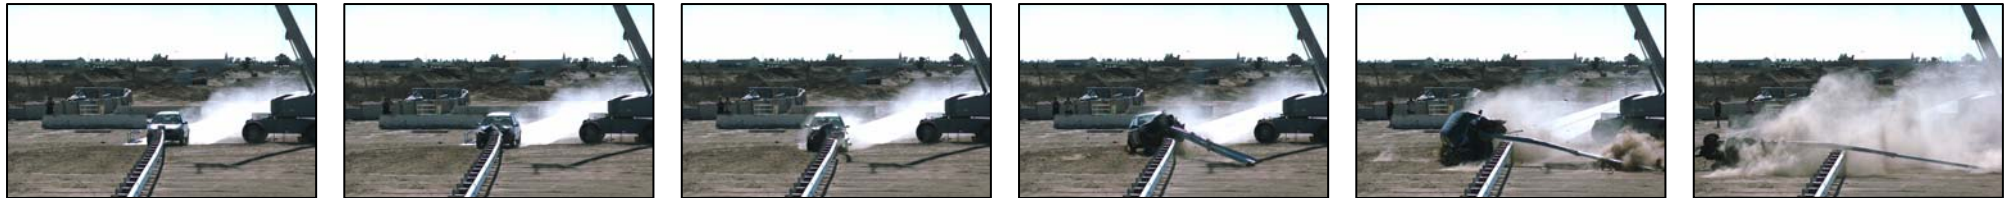
DATA SHEET 4
SUMMARY OF RESULTS

0 ms 100 ms 300 ms 600 ms 1200 ms 2500 ms

GENERAL INFORMATION		OCCUPANT RISK VALUES	
TEST AGENCY	KARCO Engineering, LLC.	FLAIL SPACE VELOCITY (m/s)	
TEST ARTICLE		X DIRECTION	5.5
TYPE	Terminal	Y DIRECTION	0.8
TERMINAL LENGTH ¹	15.2 m (59.9 ft.)	THIV (Optional) (m/s)	5.6
ADJOINING BARRIER LENGTH ²	34.3 m (112.5 ft.)	RIDEDOWN ACCELERATION (g)	
TEST VEHICLE		X DIRECTION	-20.5
TYPE	Production Model	Y DIRECTION	12.7
DESIGNATION	820C	PHD (Optional) (g)	24.1
MODEL	Chevrolet Metro	ASI (Optional)	0.97
MASS (CURB)	793.0 kg (1,748.2 lbs)	VEHICLE DAMAGE	
MASS (TEST INERTIAL)	814.5 kg (1,795.6 lbs)	INTERIOR	
DUMMY MASS	76.0 kg (167.5 lbs)	OCDI	FS0000010
MASS (GROSS STATIC)	909.0 kg (2,004.0 lbs)	POST-IMPACT VEHICULAR BEHAVIOR	
IMPACT CONDITIONS		MAXIMUM ROLL ANGLE (°)	203.1
VELOCITY (km/h)	98.94 km/h (61.48 mph)	MAXIMUM PITCH ANGLE (°)	45.6
ANGLE (°)	4.7	MAXIMUM YAW ANGLE (°)	-58.2
IMPACT SEVERITY (kJ)	307.5

The test vehicle impacted the X Lite Tangent 50' (15.24 m) System at a velocity of 98.94 km/h (61.48 mph). The test vehicle impacted the X Lite impact head and pushed rail 1 down rail 2. The downstream shear bolts connecting rail 3 and 4 sheared causing the W-beam sections to separate from the article. The vehicle remained in contact with the impact head as the W-beam section rotated toward the traffic side of the article. The vehicle rotated counter-clockwise about its yaw axis before rolling onto its roof. The test vehicles final resting position was 19.6 m (64.3 ft.) downstream from its initial point of impact. As a result of the impact the posts 1 through post 8 were bent towards the ground. W-beam sections 1 through 3 detached from the system. The impact head, ground strut and slider bracket sustained deformation. An overhead illustration of the test vehicle and test article in their pre-test and post-test conditions is shown in Figure 2 in Appendix D. Sequential photographs of the test sequence are shown on Data Sheet 4.

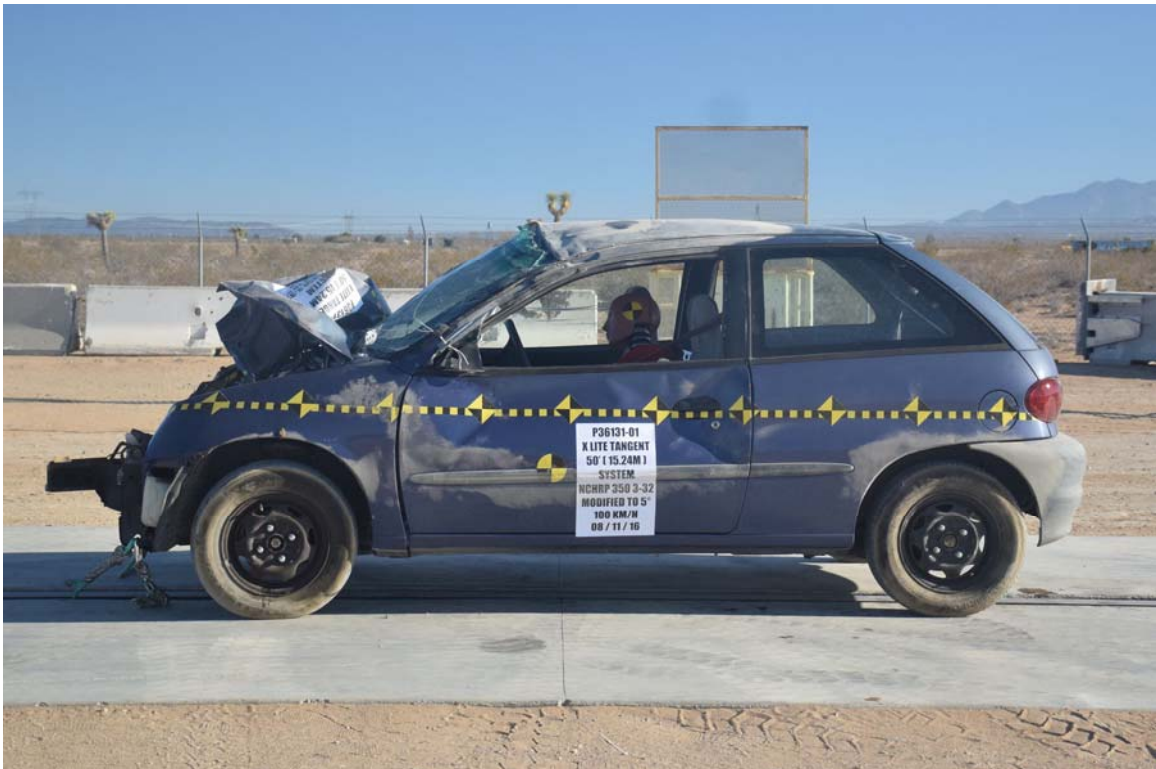
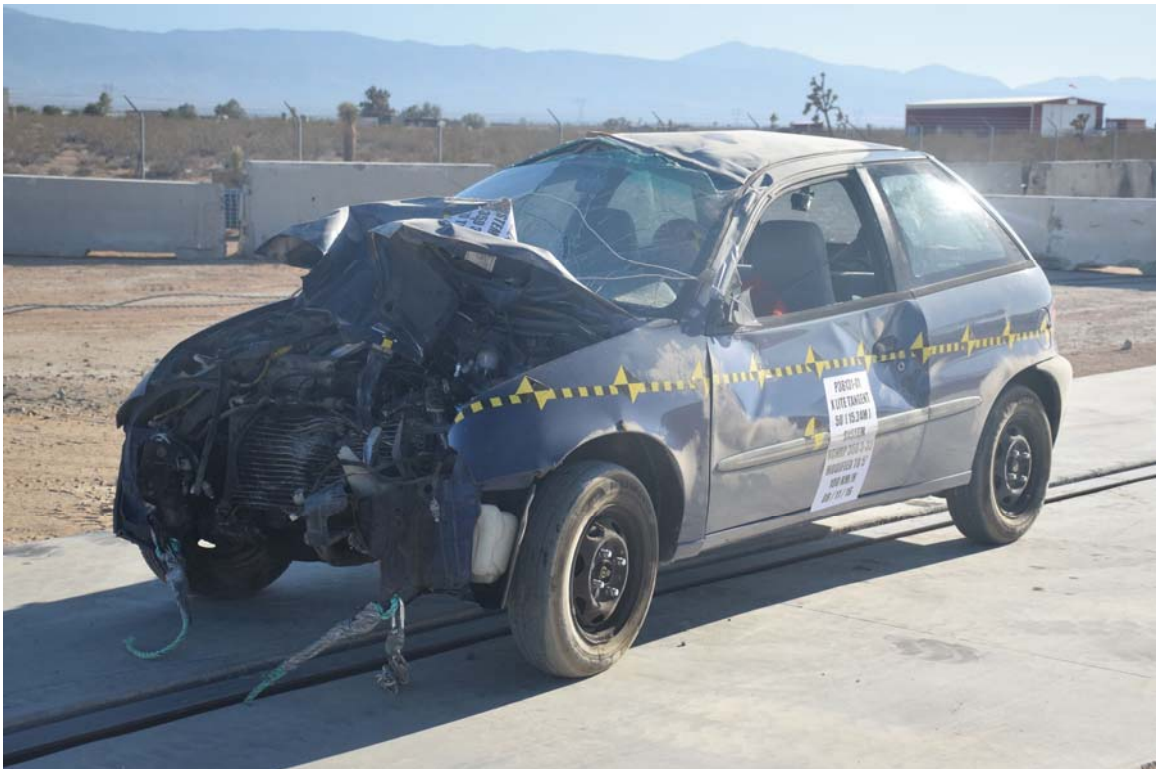
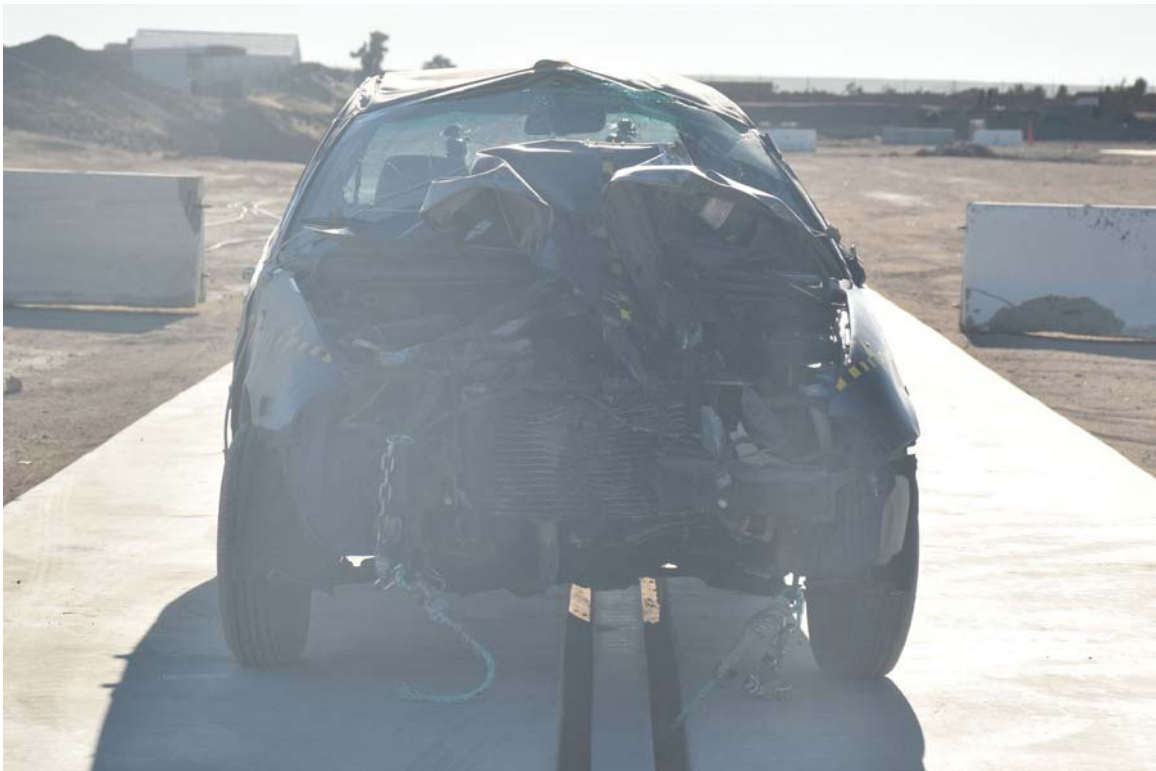
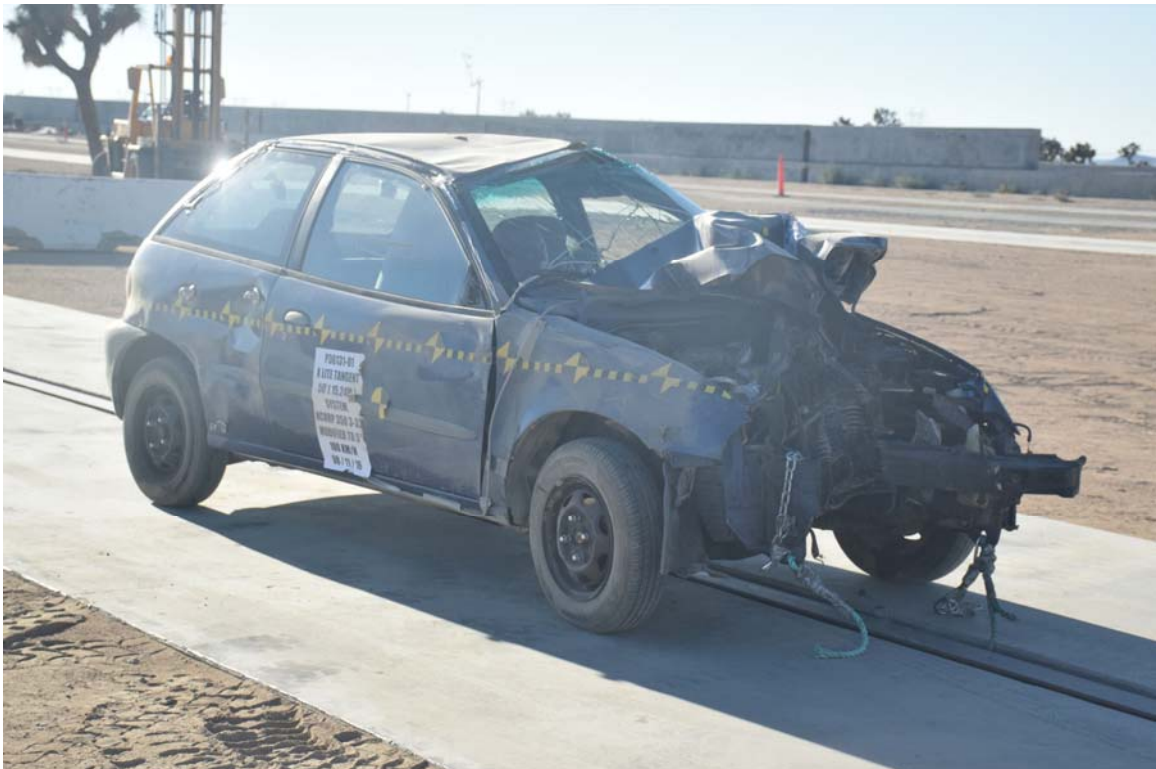
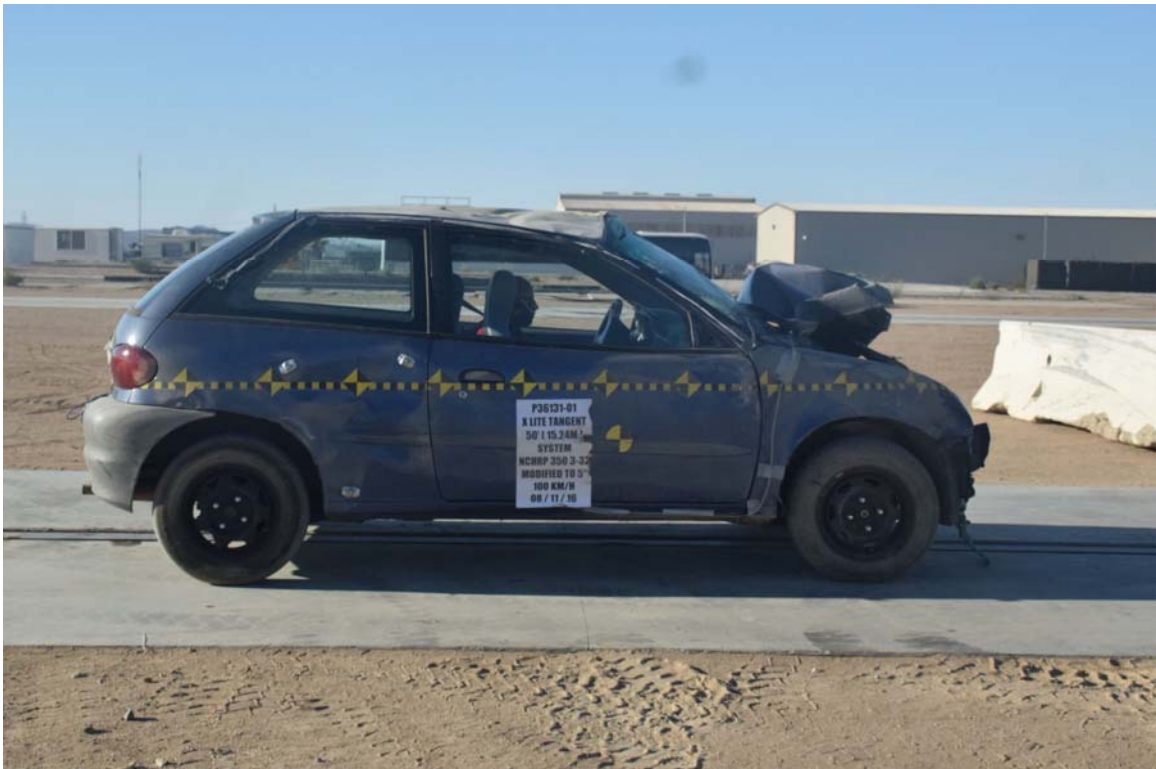
FIGURE 40. Post-Test Left View of Test Vehicle

FIGURE 42. Post-Test Left Front $\frac{3}{4}$ View of Test Vehicle

FIGURE 44. Post-Test Front View of Test Vehicle

FIGURE 46. Post-Test Right Front $\frac{3}{4}$ View of Test Vehicle

FIGURE 48. Post-Test Right View of Test Vehicle

The vehicle sustained damaged to its front end as a result of the impact with the X Lite Tangent 50' (15.24 m) System. The test vehicle's hood and front left quarter panel sustained deformation. The front bumper beam split at its center and the radiator was crushed. The occupant compartment was not penetrated as a result of the impact.

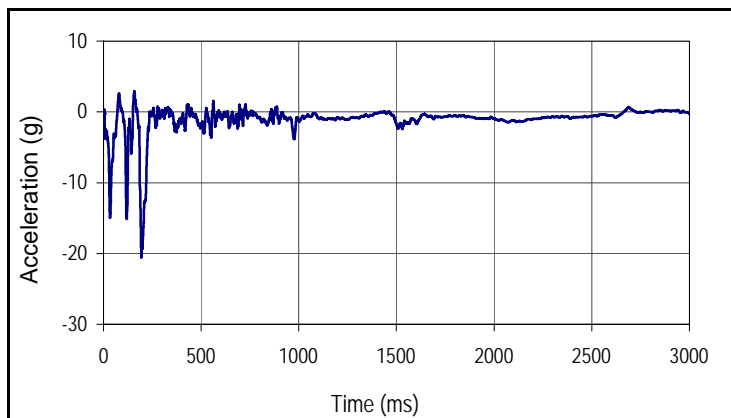
Curve Description			
Test Vehicle CG X Moving Average			
Plot No.	Type	SAE Class	Units
002	AVG	180	g
Max	Time	Min	Time
2.9	158.0	-20.5	193.8

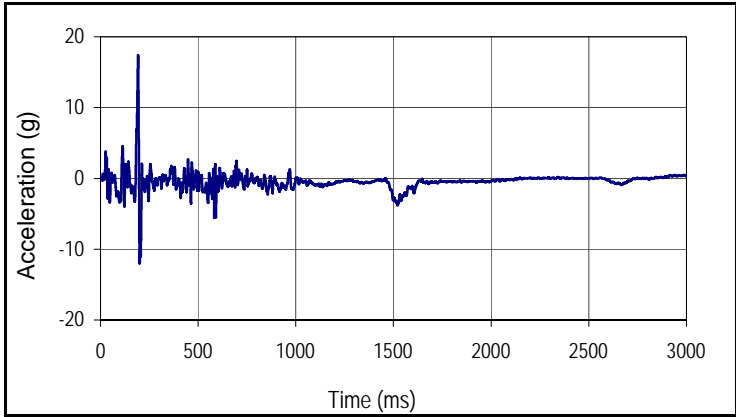
Curve Description			
Test Vehicle CG Y			
Plot No.	Type	SAE Class	Units
005	FIL	60	g
Max	Time	Min	Time
17.4	192.5	-12.0	200.5

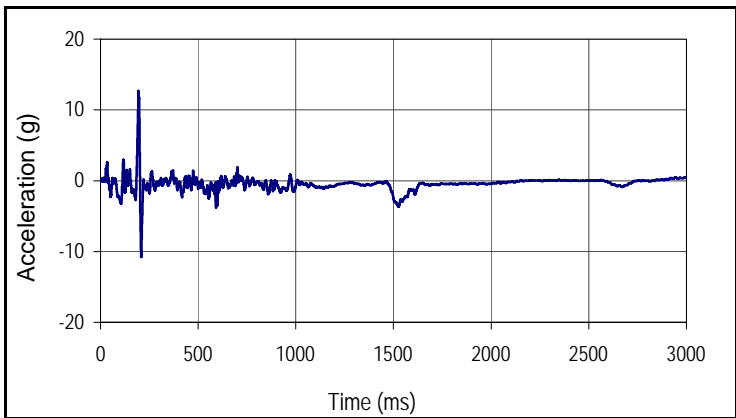
Curve Description			
Test Vehicle CG Y Moving Average			
Plot No.	Type	SAE Class	Units
006	AVG	180	g
Max	Time	Min	Time
12.7	194.0	-10.8	208.6

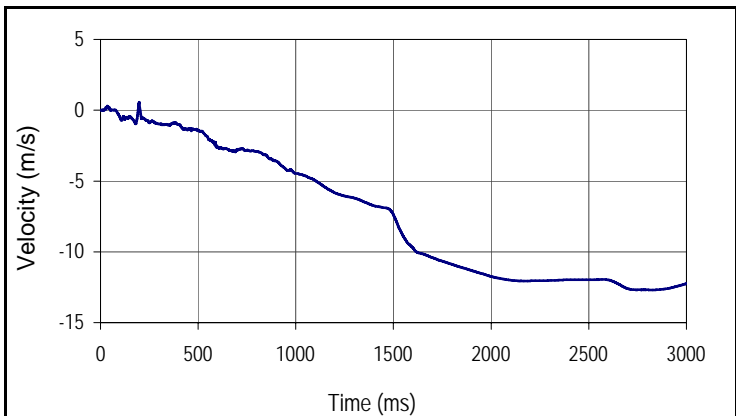
Curve Description			
Test Vehicle CG Y Velocity			
Plot No.	Type	SAE Class	Units
007	IN1	180	m/s
Max	Time	Min	Time
0.6	197.8	-12.7	2815.7

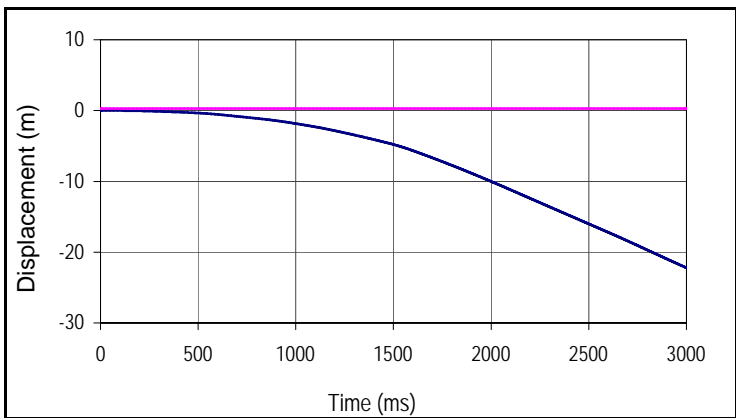
Curve Description			
Test Vehicle CG Y Displacement			
Plot No.	Type	SAE Class	Units
008	IN2	180	m
Max	Time	Min	Time
0.0	78.3	-22.2	2999.9

— Vehicle CG Y Displacement
 — Occupant Y Displacement

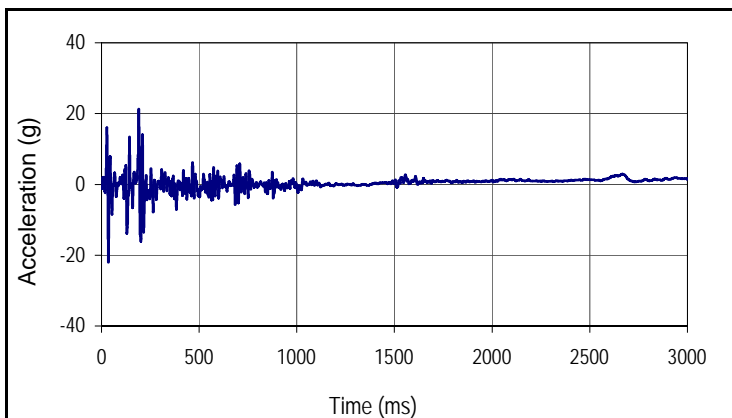
Curve Description			
Test Vehicle CG Z			
Plot No.	Type	SAE Class	Units
009	FIL	60	g
Max	Time	Min	Time
21.3	190.9	-22.0	35.2

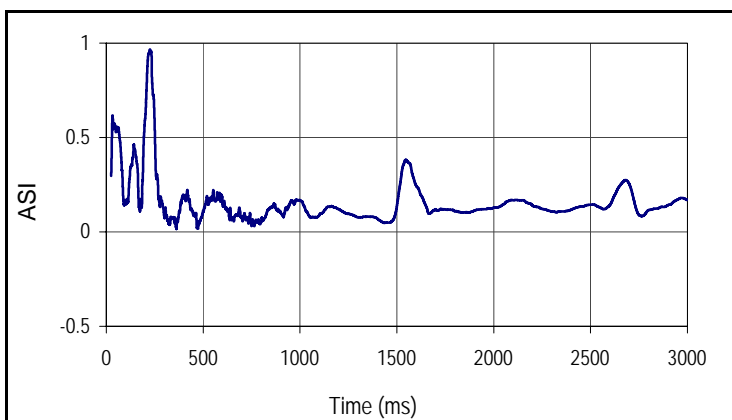
Curve Description			
Test Vehicle Accident Severity Index			
Plot No.	Type	SAE Class	Units
010	ASI	180	ASI
Max	Time	Min	Time
1.0	226.1	0.0	361.8
