BMP INSPECTION MANUAL

Instructional Manual for BMP Inspection Program and Process

Maintenance Division 1401 E. Broad Street Richmond, Virginia 23219

June 2016

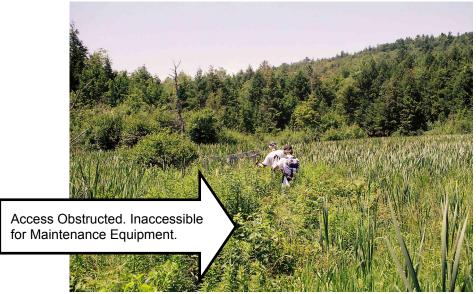
significant minor growth that would impede equipment from entering the area for inspection or maintenance. This would indicate a minor rating (2) because the access road can be easily cleared due to the small brush. If heavier grade equipment was required to restore the access road, a higher level rating

This facility has an inadequately maintained access road. There is

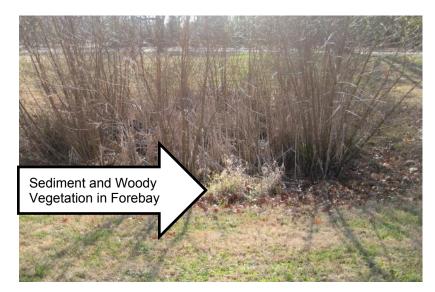
Facility is filled with a significant amount of sediment and woody vegetation, affecting the volume of storage. This would indicate a moderate rating (3) due to the substantial growth in the forebay that is affecting the storage volume.

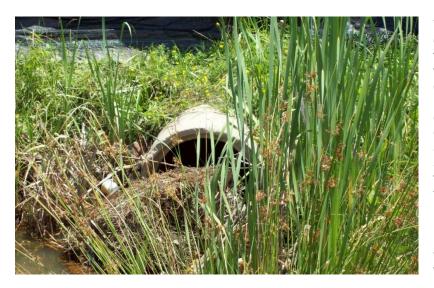
There is a significant amount of debris blocking the inflow from this pipe. This would warrant a minor rating (2) due to the minimal effort required to remove the loose debris. Also, the amount of debris present does not appear to be substantially affecting water levels in the facility and allows partial flow through the pipe. If this blockage was creating a backwater condition for the pipe that was not a part of the design, a higher rating would be warranted.

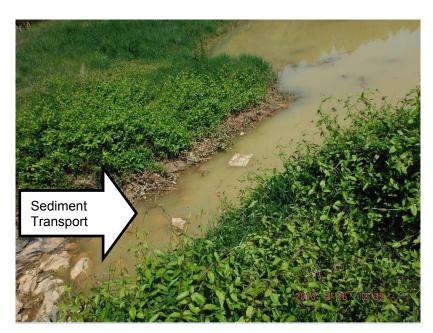
There isnot any sediment trapping mechanism for inflow to this basin, which is apparent by the severely eroded chanel. The channel is in need of stabilization and a check dam at the end of the channel would serve as a trapping mechanism. This warrants a mmajor rating (4) because of the amount of sediment being transported.

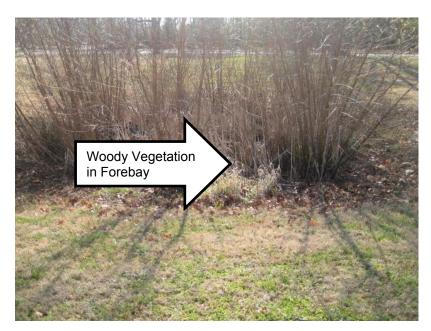
This forebay is filled with a significant amount of sediment and woody vegetation, affecting the volume storage. This warrants a moderate rating (3) due to the substantial growth in the forebayand effort required to remove it.

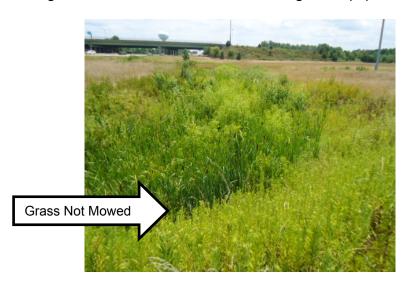
Vegetation is overgrown, and negatively affecting the facility. This would indicate a minor rating (2) because of the minor effort required to mow the area. If the vegetation was woodier and more brush like or difficult to access with proper equipment, a higher rating would be warranted.

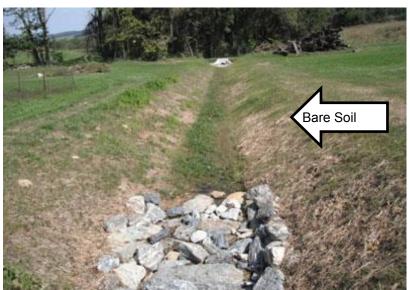
and adjacent areas are unstable and contributing to sediment buildup within the facility. This indicates a minor rating (2), due to the size of the area and minor effort required for stabilization. If the sedimentation is affecting the functionality of other facility components, a higher rating is warranted.

The outlet channel structure

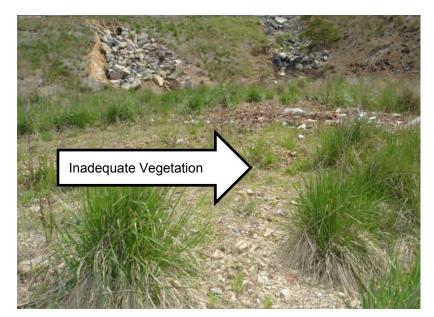
There is inadequate vegetation in this facility, which significantly impacts the water quality and ground stability. This would indicate a minor rating (2), reflecting the need for routine maintenance. The plans should be referenced to determine any specific planting requirements. If the facility requires a complete replanting of 50% or more of the design plantings, then a higher rating is warranted.

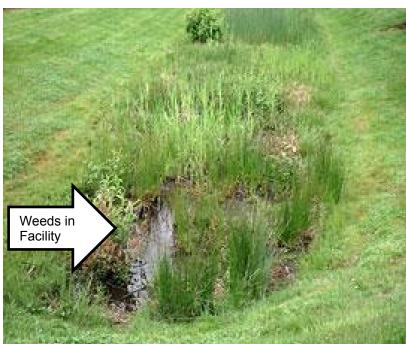
There is a significant amount of weeds present in this facility. Weeds can impact the storage volume and water quality benefits. This indicates a moderate rating (2) and can be addressed by routine maintenance. The planting plan should be referenced to determine which plants should remain, be removed or be replanted.

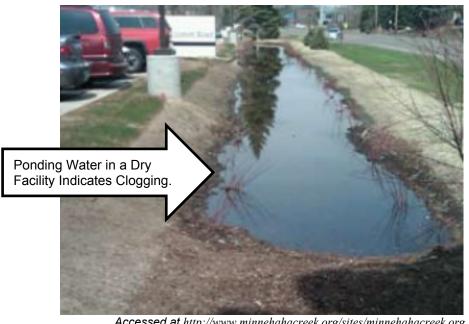
The filter media in this facility has become clogged which is causing ponding of the water. This warrants a major rating (4) because clogging can cause the water level to rise and pose a risk to persons and property. This rating can be raised or lowered based on proximity to the public road and/or property which presents a safety threat.

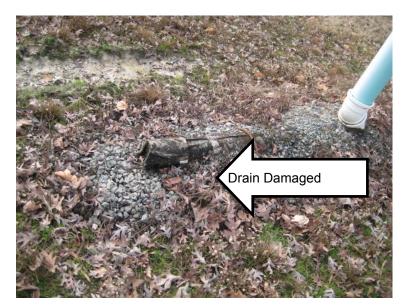
The drain in this structure has become damaged and has heaved out of the ground. This significantly reduces the operation of the drain. This is a minor rating (2) because the facility still drains; however, repairs need to be made to the underdrain. If the elevation difference prevented the facility from draining or significantly raised the water level a high rating is warranted.

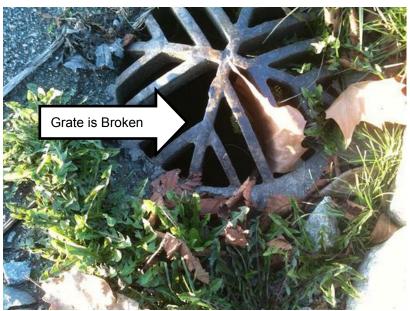
The grate on this facility has broken off which allows debris to enter the facility. This is a minor rating (2) because the broken section is small and is not causing a performance or safety issue. If this grate were in a public area where safety was a concern, a higher rating would be appropriate. A higher rating would also apply if the broken grate area was large enough to allow debris to entirely block the outlet structure including inside the pipes.

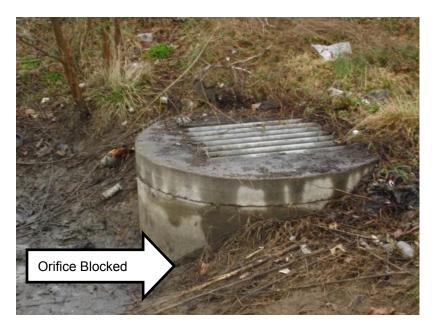
This structure has a large amount of sediment and debris preventing the water from draining properly. This warrants a moderate rating (3) because this could raise the waer level. If the top outflow structure were also 100% blocked a major (4) rating would be warranted during large storm events. Debris lines on the facility slopes are good indicators of flow levels, and function of the facility.

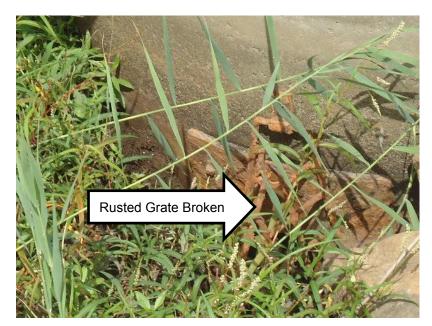
The grate has rusted and is broken. This could cause the grate to completely break loose and allow debris to clog the low flow orifice. This is a minor rating (2) because it is not allowing debris to enter the facility at this time but should be repaired as preventative maintenance.

Check if applicable. Grates prevent debris and trash from entering the outlet structure and causing blockages. Corrosion is common on grates and should

be monitored for full deterioration, i.e. completely eaten away. Cleaning grates should be a part of routine maintenance, and is much easier to accomplish than cleaning the outlet structure.

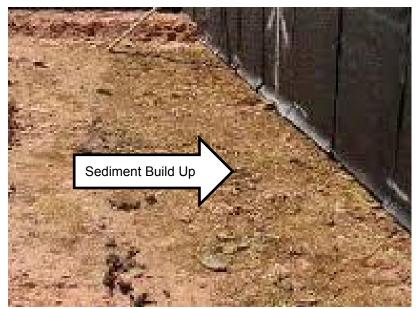
There is a significant amount of sediment build up. This is affecting the filtration capabilities of this facility. This is a major rating (4) because the sediment in the chamber is completely blocking the media, causing high water levels during rain events and preventing proper treatment.

Chambers are associated with Filtering Practices 1 and 2 CH facilities. Per the BMP clearinghouse if there is 6" or more of sediment in the chamber, the sediment should be removed. This sediment in the chamber prevents proper function of the facility.

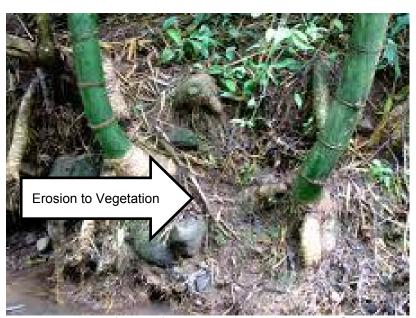
There is a significant amount of erosion occurring around these plants. Exposed roots can cause plant stress and minimize nutrient uptake. This warrants a minor rating (2), since this can often be corrected by adding additional outlet protection at the facility's discharge point and replacing eroded soil to ensure proper root coverage. Consider additional erosion control measures to prevent or reduce erosion.

Check this box if there is erosion impacting the planting areas or root systems. This issue could result from different causes, such as high velocity flows due to inadequate outlet protection or frequent storms larger than the design level of the facility. Determining the cause of the erosion is critical to achieving a long-term remedy for the problem.

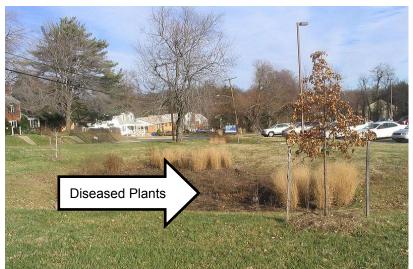
The plants in this facility are diseased, dying and/or stressed. This impacts the pollutant removal capabilities. This warrants a moderate rating (3) because the plants are a main design component regarding water quality and stability of the facility and none have survived.

Check if plantings are deteriorating from unknown stressors. Note that locating the type and source of the stressor is critical to achieving the desired restoration, and note that the source may be considered an illicit discharge. If so, please see the "Illicit Discharge" item listed under "Overall Function of Facility" heading, as described below.

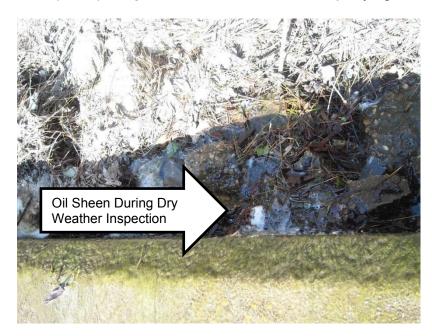
This oil sheen can be seen entering the facility during a dry weather inspection.
This warrants a moderate rating (3) and the VDOT IDDE Manual should be referenced for further guidance on reporting and inspection of the potential ID.

Check, if applicable. Evidence of an illicit discharge can be oil sheens on the water surface or vegetation, atypical odors or colors of substances, or sediment in the facility among others. If there is a possible Illicit Discharge (ID) discovered, report it in accordance with the notification instructions and guidance discussed in VDOT's Illicit Discharge Detection and Elimination (IDDE) Program Manual and the accompanying Field Guide.

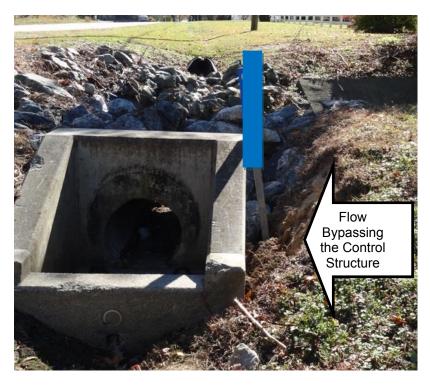
The flow in this picture is bypassing the control structure and has caused a dam breech. Bypassing flows in a filtration structure are typically evident by erosion and scour indicative of flow around a structure or debris paths that circumvent the outlet/inlet. If drainage bypasses the inlet structure into the facility (i.e. flows outside of the inflow channel) but still connects drainage to the control structure, it warrants a minor rating (2). If it bypasses the control structure during large storm events, rate it as moderate (3). If it is bypassing the outlet structure on a regular basis, rate it as major (4). In the case shown above, it would also be rated as a dam breech in other sections of the inspection form, which increases the overall facility rating to a failure level (5).

Check, if applicable. If the flow is bypassing the control structure, principal spillway or related design features, then the flows are not being properly treated and the required pollutant removal is not being achieved. Flow bypass can result from many different causes, such as sedimentation causing a lack of positive drainage, a blocked outlet structure, or vegetative overgrowth. This is a minor to moderate (2-3) rating item, depending on the ability to meet pollutant removal requirements.

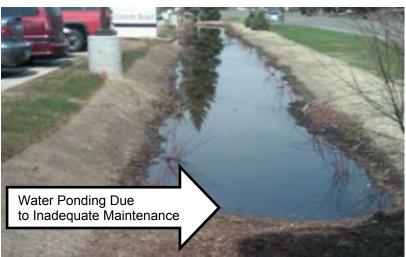
The filter media in this facility has become clogged which is causing ponding of the water. This is a major rating (4) because clogging can cause the water level to rise and pose a risk to persons and property.

Standing water in a filtration facility for more than 48 hours after a storm event indicates other issues, such as clogged media and potential blockages. Observation wells are recommended to monitor infiltration visually and to note time durations for drainage. This item is typically rated as minor to moderate (2-3).

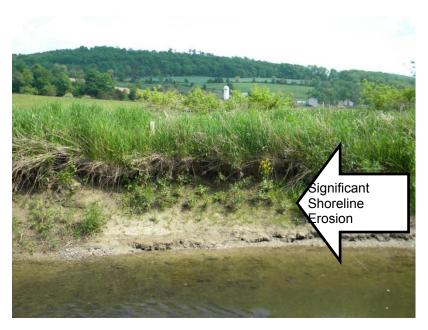
The shoreline of this facility has significantly eroded. There are many factors that could play a part in contributing to this condition. This warrants a minor rating (2) because it is fairly well stabilized and the water is clear, indicating little to no sediment pollution at this time.

Notate any erosion caused by or within these facilities. Shoreline erosion is particularly difficult to remedy because sandy soils do not have strong cohesion and compaction. This warrants a minor to moderate (2-3) rating based on the severity of erosion.

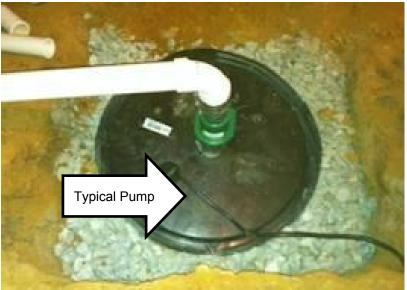
This photo is a picture of a pump. Pumps come in many shapes and sizes and usually consist of an intake structure, a pump motor, an outlet pipe, and a power source.

Some filtration systems have pumps to drain the facility during storm events of certain sizes. Depending on the frequency of needed pumping and the level at which the pumps engage, this item warrants a minor to moderate (2-3) rating.

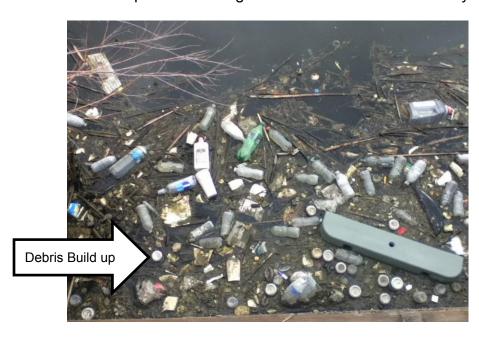
This facility is filled with a significant amount of natural debris and trash, affecting the volume of storage. This warrants a moderate rating (3) due to the substantial growth in the forebay that is affecting the storage volume.

Check, if applicable. Debris in an infiltration type facility can inhibit the ability of water to migrate to the filtration media. It can also be a source of silt or sediment that blocks the filtration media. Pretreatment areas are designed to catch debris and prevent it from entering the facility. Therefore, they require more frequent debris removal than the infiltration area itself. This item also

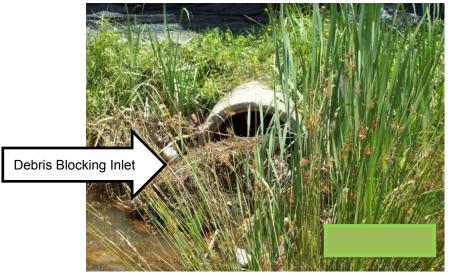
There is a significant amount of debris blocking the inflow from this pipe. This would warrant a minor rating (2) due to the minimal effort required to remove the loose debris. Also, the amount of debris present does not appear to be substantially affecting water levels in the facility and allows partial flow through the pipe. If this blockage was creating a backwater condition for the pipe that was not a part of the design, a higher rating would be warranted.

Check, if applicable. Debris in an infiltration type facility can inhibit the ability of water to migrate down to the filtration media. It can also be a source of silt or sediment that blocks the filtration media. This is a routine maintenance item with a minor rating (2) unless removal of the debris is more extensive, which warrants a higher rating. When inspecting, identify any trash or debris that could potentially be considered an illicit discharge. This topic is further discussed under the component heading "Overall Function of the Facility".

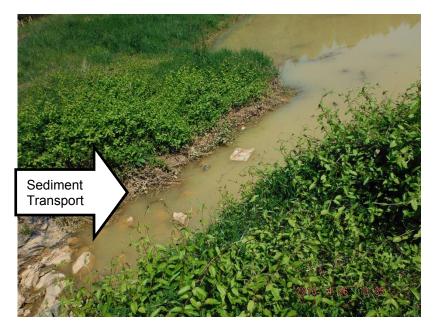
There isn't any sediment trapping mechanism for inflow to this basin, which is apparent by the severely eroded chanel. The channel is in need of stabilization and a check dam at the end of the channel would eserve as a trapping mechanism. This warrants a major rating (4) because of the amount of sediment being transported.

Check, if applicable. This item describes deterioration of the pretreatment areas to the extent that they are not functional. Inflow initially goes through a pretreatment component to remove sediment and debris prior to drainage entering the main facility. This component can take the form of a sediment trap, a forebay or a swale that directs runoff into the facility. Removal of debris and trash is covered under routine maintenance in the "Debris" component heading. Be aware that in many cases the pretreatment structure includes some amount of designed storage volume for the facility, and impacts to this must be considered in the rating.

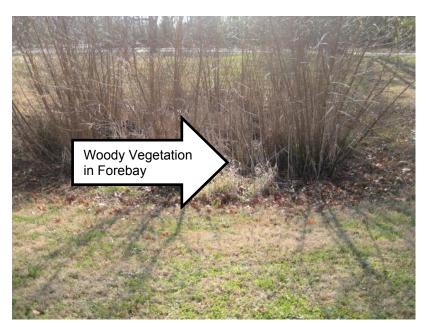
This facility is filled with a significant amount of sediment and woody vegetation, affecting the volume of storage. This warrants a moderate rating (3) due to the substantial growth in the forebay that is affecting the storage volume and the level of effort needed for repairs.

Check if applicable. Pretreatment areas, particularly forebays, are designed to hold 10% - 15% of the required storage volume, so a loss of 50% of that capacity can impact the water level in the main facility and impair its function. This is more applicable to forebays than pretreatment swales, which do not store part of the treatment volume. Locating the source of erosion or sedimentation upstream, which may be considered an illicit discharge, is critical to minimizing future maintenance of the facility. If the sediment is considered an illicit discharge, refer to the illicit discharge items listed under component heading "Overall Function of Facility".

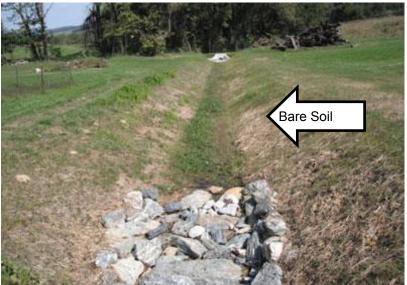
The contributing drainage area to this grass swale is unstable and is contributing to sediment buildup within the channel. This warrants a minor rating (2).

Proper stabilization is critical to keeping the BMP operational. The source of the sedimentation or instability (sloughing, etc.) should be identified and remedied as part of this process, as well as the unstable area. For example, an upstream area that previously drained as sheet flow may receive additional drainage, turning into concentrated flow. This flow may be eroding the area, making it unstable. In this case, the unstable area and concentrated flow should be stabilized to prevent future impacts. This repair is a part of routine maintenance, and a minor rating (2) is appropriate unless the area requires more extensive repairs or impacts the structural integrity of the facility.

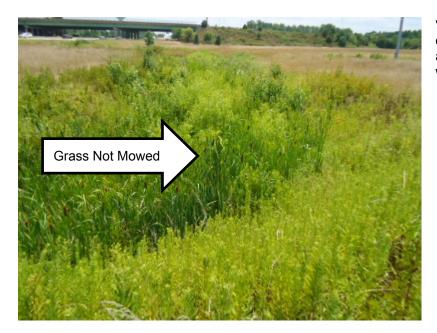
Vegetation is greatly overgrown, and negatively affecting the facility. This warrants a minor rating (2).

The infiltration area should be mowed and clippings should be removed a minimum of twice a year to avoid impacts to the filter bed. Even shallow root systems can impact the facility's ability to filter runoff and drain within a certain time frame. This repair is a part of routine maintenance, so a minor rating (2) is appropriate. The rating can be upgraded, as needed, based on the degree of the work to be performed by the locality.

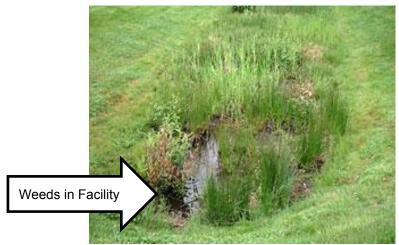
There is a significant amount of weeds present in this facility. Weeds can impact the storage volume and water quality benefits. This warrants a moderate rating (2) and can be addressed through routine maintenance. The planting plan should be referenced to determine which plants should remain or need to be replanted.

Weeds are not a part of the landscape design for infiltration facilities. They evolve naturally and should be removed a minimum of twice a year as part of routine maintenance. The proper rating would be a 1 for no problem or 2 for minor issues, based on the amount that must be removed and its relative location. Weeds may also be indicative of sediment in the media bedding, since it promotes their growth. If the weeds are taking up storage volume in the infiltration media, choking out required plantings, or slowing flow, then a higher rating may be justified.

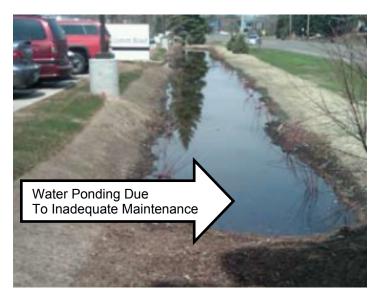
The filter media in this facility has become clogged, which is causing standing water. This is a major rating (4) because clogging can cause the water level to rise higher than expected, posing a risk to persons and property.

If water is still standing in the facility 48 hours after a storm event, the infiltration media may be clogged. Other indicators of clogging include dry sediment residue on the top surface of the facility. To further verify that clogging is occurring, rake the top 3" of the media and visually inspect for discoloration. A higher rating is warranted if replacement of the media is required.

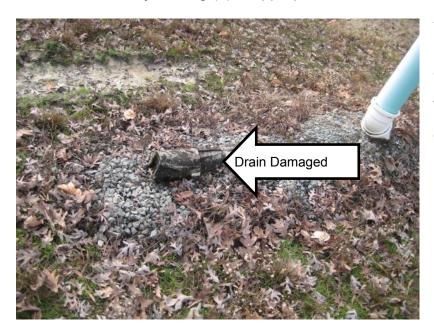
The drain in this structure has become damaged and has heaved out of the ground. This significantly reduces its operation. This warrants a minor rating (2) because the facility still drains; however, repairs need to be made to the underdrain.

Check if there is structural deterioration of the inlet or outlet structures. This warrants a minor rating (2) unless the deterioration is directly affecting the facility's ability to fully function. For example, if the underdrain is crushed or fully blocked, such that the facility cannot contain or properly treat the high flow events, a major rating (4) is appropriate.

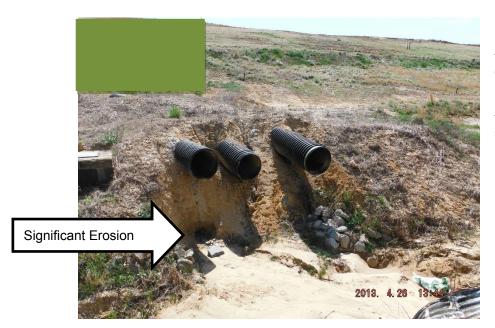
Inadequate stabilization and high flow, among other things, can cause the erosion evident in this picture. This warrants a moderate rating (3) due to the significant erosion and sediment deposition. Outlet protection and backfill may be warranted in this case.

Check, if applicable. Look for erosion of the facility areas where (1) the inflow channel discharges runoff into the BMP and (2) the outflow structure discharges flow from the BMP. Evidence of erosion includes soil loss at the channel outlet, soil loss around the edges of the outlet protection (if present), and displaced or missing outlet protection. If the riprap is transported downstream or displaced, it signifies that the stone size is too small, whereas

erosion or scour at the edges of the riprap indicate that the riprap footprint dimensions are not large enough.

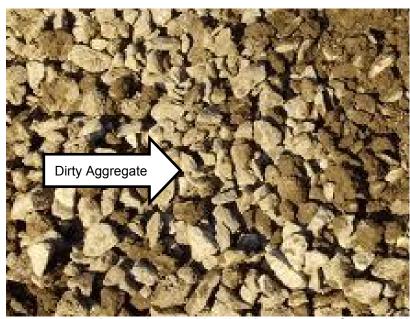
The aggregate in this infiltration facility has become clogged with sediment from the contributing drainage area. This warrants a minor rating (2), because it is not very deep nor does it have a large footprint

Check, if applicable. For the facility to properly function, the designed storage volume in the aggregate voids must be available for all storm events, and not reduced by sediment or other obstructions. This warrants a minor rating (2) if there are no significant changes to functionality. However, if there are significant impacts to the storage volume, which would require aggregate replacement, then a major rating (4) is appropriate.

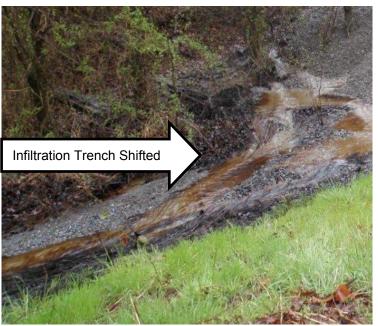
This infiltration trench has shifted due to high flow velocities that have dislodged the rock. This warrants a major rating (4) because the trench has completely disintegrated due to high velocities and flow volumes.

Check, if applicable. The trench serves to hold the filter media in place at the proper volumetric dimensions. It is also wrapped in filter fabric to prevent surrounding soil from piping into the aggregate. This warrants a minor to major (2-4) rating, depending on the level of degradation of the trench. If the trench has shifted or settled in an isolated area but functionality doesn't appear to be affected, this warrants a minor (2) rating. If a large section of the trench has settled in a manner that impacts the storage volume, flow rates, or causes flow to bypass the facility a major (3) rating is appropriate.

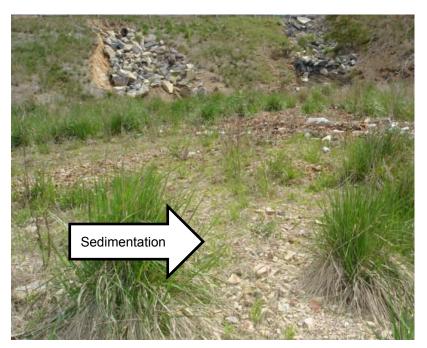
Sediment has built up in the facility and is affecting the ability and time to infiltrate. This is a moderate rating (3) as the facility is still draining but sediment needs to be cleaned for it to operate as designed and not raise water levels. If additional structures are being engaged in storm events less than design levels the rating should increase. Additionally, the depth of media affected by sediment and needing replacement may warrant a higher rating.

Evidence of significant sediment build-up would include dried or cracked silt deposits on the media surface, waterlines above the design storm elevation, or discoloration of the media. Vegetation is also a sign that significant sediment is present, thus promoting plant growth. Take note of the water level indicators in and around the facility, such as sediment or debris lines on the slopes. These are good indicators of the impact sedimentation has on the function of the BMP. Also, locating the source of erosion or sedimentation upstream is critical to effectively addressing this issue, and be aware that sedimentation may be an indication of an illicit discharge. If so, please see the illicit discharge item listed

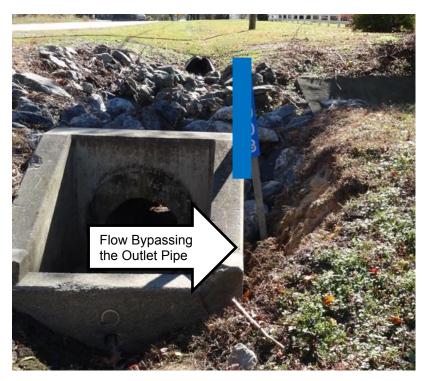
The flow in this picture is bypassing the control structure and has caused a dam breech. Bypassing flows in an infiltration structure are typically indicated scour on the inflow side of the control structure or flow debris paths that circumvent the outlet/inlet. If drainage bypasses the inlet structure (i.e. flows outside of the inflow channel) but still connects drainage to the control structure, this warrants a minor rating (2). If it bypasses the control structure during large storm events, a moderate rating (3) is appropriate. If it is bypassing the control structure on a regular basis, give it a major rating (4). In the case shown in the photo. it would also be rated as a dam breech under another category heading, which should increase the overall facility rating to failure (5).

Check, if applicable. If the flow is bypassing the control structure, principal spillway or related design features, then the flows are not being properly treated and the required pollutant removal is not being achieved. Flow bypass can have many different causes, such as a blocked outlet structure, vegetative overgrowth, or sediment accumulation causing a lack of positive drainage. This warrants a minor to moderate rating (2-3), based on the ability to meet pollutant removal requirements.

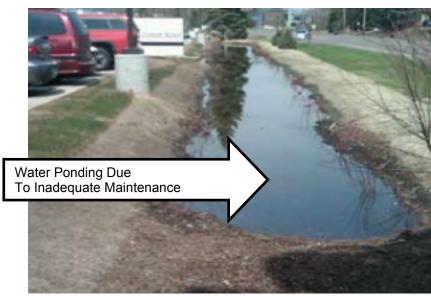
The storage aggregate in this infiltration facility has become clogged, which is causing the water to pond for longer than normal. This warrants a major rating (4), because clogging can cause the water level to rise and pose a risk to persons and property.

Standing water in an infiltration facility for more than 48 hours after a storm event indicates other issues, such as clogged media and potential blockages. Observations wells are recommended to monitor the infiltration rates visually and to note time tables for drainage. This warrants a moderate to major rating (3-4).

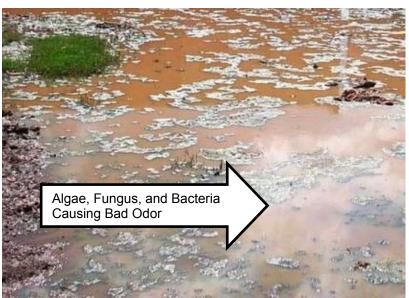
The cause of the bad odor in this facility is algae, fungus, and bacteria. Typically there are other inspection deficiencies causing this condition. This warrants a minor rating (2).

Odors are indicative of stagnant water containing algae, fungus and bacteria. All of these are indicators that the facility is not properly functioning. Odor may also be an indication of an illicit discharge (see below).

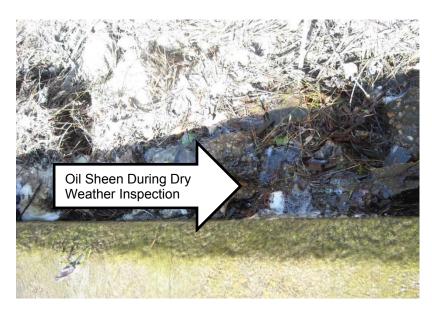
An oil sheen can be seen entering this facility during a dry weather inspection. This warrants a moderate rating (3), and the VDOT IDDE Manual should be referenced for further guidance on reporting and correcting the potential illicit discharge.

Check, if applicable. Oil sheens on the water surface, atypical odors, persistent abnormal colors, or high levels of sediment in the facility can all be evidence of an illicit discharge. If there is a possible illicit discharge discovered, report it following the notification instructions and guidance provided in VDOT's *Illicit Discharge Detection and Elimination Program Manual* and associated *Field Guide*.

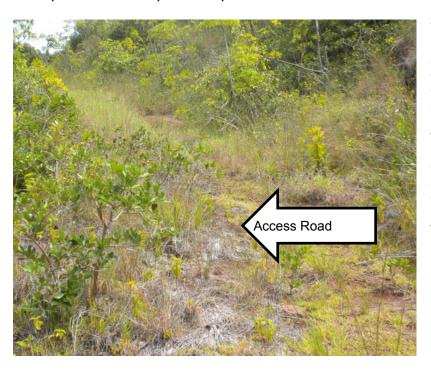
This facility has an inadequately maintained access road. There is minor growth that would impede equipment from entering the area for inspection or maintenance. This would warrant a minor rating (2), because the access road can be easily cleared of the small brush. If larger equipment was required for repairs, a higher rating would be appropriate.

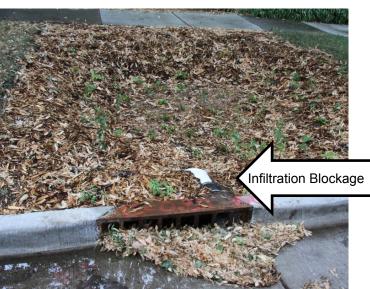
A significant amount of debris is blocking this inlet and, likely, the filtration media. The debris would have the same effect on an underground manufactured structure as it would at a "tree box filter" structure, shown here. This would warrant a moderate rating (3), due to the backwater created on the adiacent roadway when other paved

s remain dry. Potential impacts ublic safety increase the rating from minor (2), which would apply to debris removal with minimal effort as a part of routine maintenance. The rating would be higher if there was limited access due to the facility being located underground, a higher level of effort is necessary to remove the debris, or there are backwater effects or other impacts to public safety.

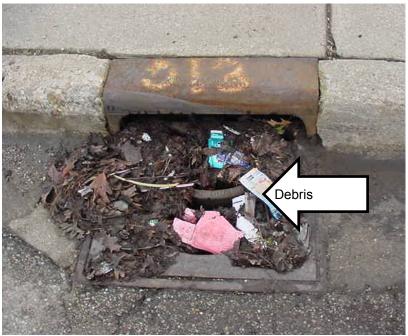
This BMP inlet is blocked by leaf debris and trash. This warrants a minor rating (2), due to the minor effort required for maintenance. If the blockage was creating a backwater, creating a public safety issue, or required a greater maintenance effort, an increased rating would be appropriate.

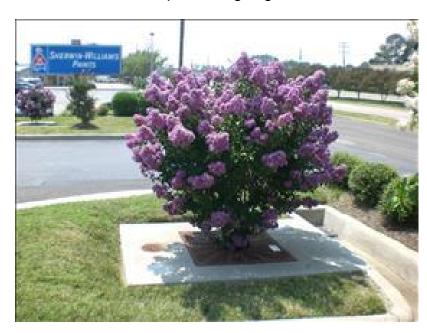
This is an example of a well maintained tree box filter, free from debris and erosion. If erosion was present you would see it around the tree base when removing the lid. uptake. This warrants a no problems rating (1), since no visible maintenance is needed.

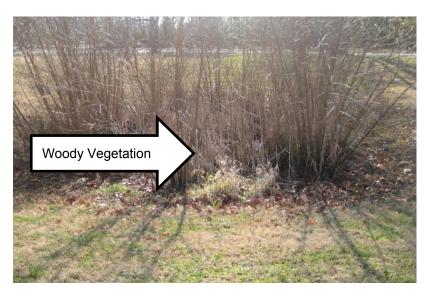
Most manufactured treatement facilities are below ground. However, root systems can penetrate into the underground facility, damaging the structural components. If there is heavy growth over the storage structure, the rating should be higher than growth over other parts of the system. This warrants a moderate rating (3), due to the woody growth and the moderate level of effort required for maintenance. If there was evidence of increased water levels or impacts to persons and properties, a higher rating would be appropriate.

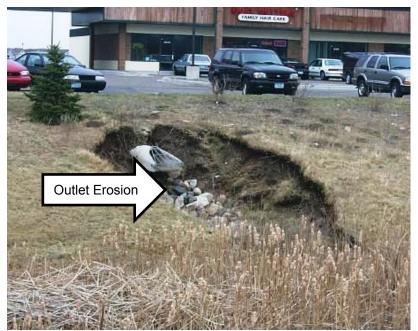
This outlet structure failure has caused severe erosion around the outlet pipe. This warrants a major rating (4) and should be corrected quickly to prevent permanent damage to the end section of the pipe or potential injury to persons and property because of its proximity to the parking area and commercial structures.

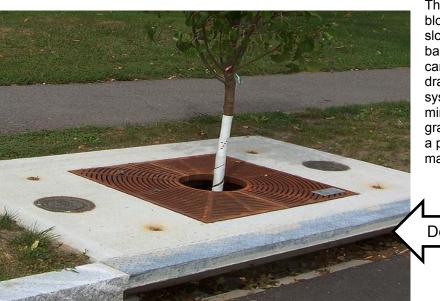
This curb inlet is partially blocked by debris which slows flows, causes a backwater condition and can also cause untreated drainage to bypass the system. This warrants a minor rating (2), and the grate should be cleaned as a part of routine maintenance.

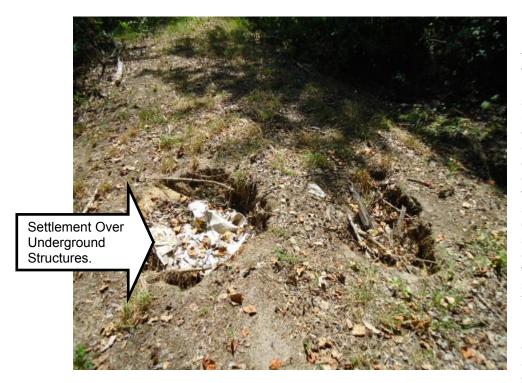
Many manufactured treatment facilities are underground systems. Settlement of the ground above it can be indicative of structural deterioration within the system. This can occur from joints separating or cracks or defects within the structure itself. This is a moderate rating (3) as the above ground has settled some. If outflow was sediment laden. the rating would be higher.

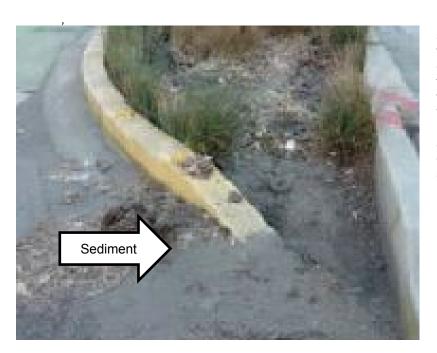
Sediment is entering the system through a curb cut in this picture. Sediment cloggs the filter media below the tree box and also clogs the filter media in high volume situations. This is a minor rating (2) due to the amount of sediment and effort to remove it. If the sediment was causing a backwater condition a higher rating is warranted.

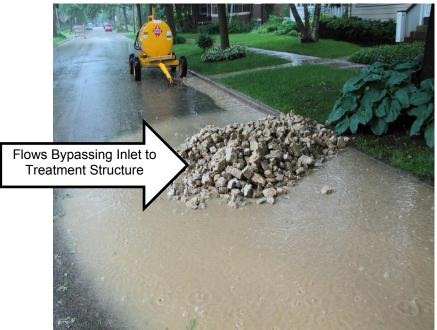
The flow in this picture is bypassing the inlet to the treatment structure and is flowing into the system downstream untreated. Bypassing flows in a manufactured treatment facility are typically indicated by sediment and flowlines near the structure inlet. If drainage bypasses the inflow structure into the facility (i.e. flows outside of the inflow channel) but still connects drainage to the treatment structure, it warrants a minor rating (2). If the flow bypasses the control structure during large storm events, rate it as moderate (3). If it is bypassing the outlet structure on a regular basis it rates as major (4).

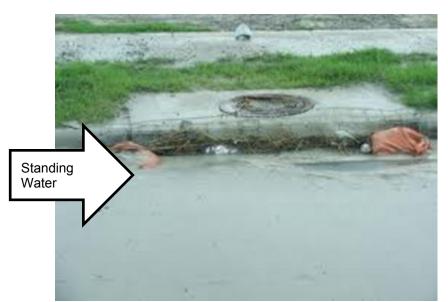
The standing water at this roadside inlet, within a specified time from the manufacturrer, is evidence of a potential problem. This warrants a major rating (4), because the high water level during certain storm events can be a risk to persons and property. There are causes of standing water, such as debris blockages and others, which are addressed under other component headings in the inspection form.

If "Standing water" is present the rating should be based on the amount of standing water, length of time present, and how the operation of the treatment facility is affected. If it is an isolated small area, perhaps caused by a trash rack blockage, a minor rating (2) is appropriate. If the standing water is the result of a blockage that is interfering with the treatment process, a major rating (4) is warranted.

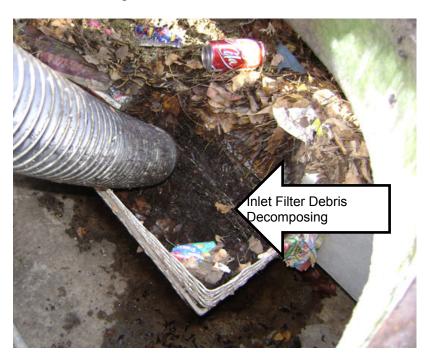
Debris and sediment that builds up in manufactured systems inlets may produce bad odors when decomposition begins. This warrants a minor rating (2), but it is indicative of other issues to address.

If "Odor" is present, it usually indicates the presence of long-term stagnant standing water. Depending on the nature and source of the odor, a minor to moderate rating (2-3) should be given. However, this odor could be caused by an illicit discharge (e.g., a chemical or sewage leaking into the facility), which requires referring to VDOT's *Illicit Discharge Detection and Elimination Program Manual* and the associated *Field Guide* for proper reporting procedures.

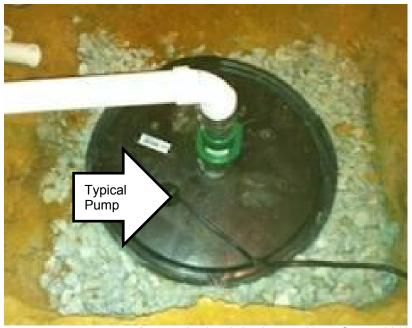
A typical pump consists of an inlet structure, the mechanical pump motor, an outlet pipe, and an electrical connection. Abnormal water levels may indicate the pump is not properly functioning. The rating is based on the level of pump function and how frequently it is used based on the design.

If "Failed pumps" is checked, the level of failure and frequency of use should be reflected in the rating. If the pumps are partially working and only engage very infrequently (e.g., for a 100-year storm), then the rating would be minor (2). If the pumps are required to function during each design storm event (e.g., the 1-inch, 2-year or 10-year storm) but have fully failed, a major rating (4) is appropriate.

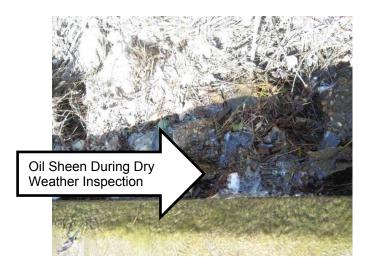
An oil sheen can be seen entering this facility during a dry weather inspection. This warrants a moderate rating (3), and the VDOT IDDE Manual should be referenced for further guidance on reporting and correcting the potential illicit discharge.

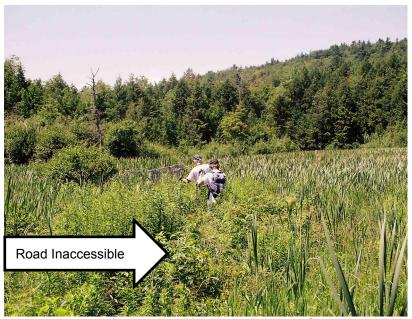
This facility has an inadequately maintained access road. There is significant vegetative growth that would impede equipment from entering the area for inspection or maintenance. This warrants a minor rating (2) because the access road can be cleared without the need for large construction equipment. This could be achieved through routine maintenance.

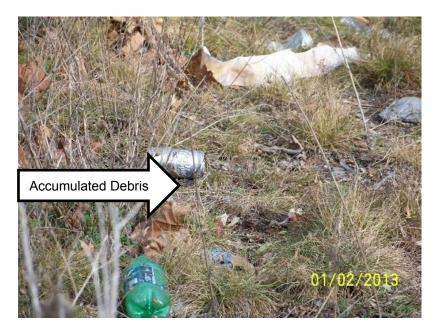
This facility is filled with debris, potentially affecting the storage volume and blocking flow to or within the BMP. This warrants a minor rating (2) and can be addressed through routine maintenance. The rating should be higher if the debris is blocking flow and causing elevated water levels, or if there is a more significant amount of effort required to remove the debris.

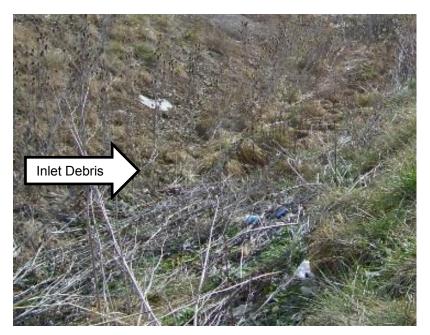
This channel has debris that is affecting drainage. This warrants a minor rating (2) and can be addressed through routine maintenance. A higher rating would be warranted if the debris slowed the inflow such that it caused a backwater effect or created a significant blockage, affecting flow rates.

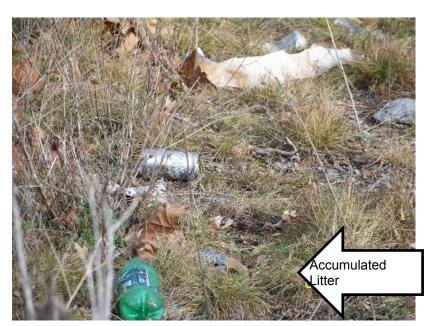
The contributing drainage area of the BMP is filled with litter, potentially affecting the storage volume and causing flow blockages. This warrants a minor rating (2) and can be addressed through routine maintenance. In some cases, yard waste such as leaf litter or other debris can become compacted and cause a complete blockage of flow, which would warrant a higher rating.

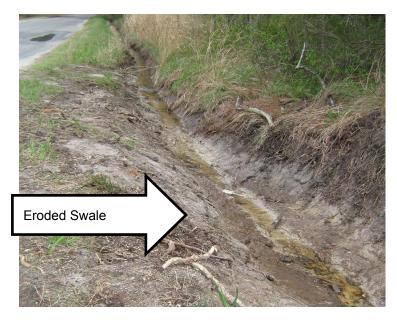
Erosion in the grassed swale is present and impacting the funtion and infiltration of the facility. This warrants a moderate rating (3), to repair the minor erosion and restabilize the area. If additional fill was needed to bring the area back to grade a higher rating is warranted.

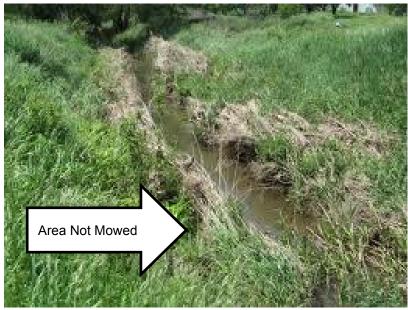
This grass swale area has not been mowed. In addition, there is evidence that previously trimmed grass has not been removed, which can create blockages and transport nutrients downstream. This warrants a minor rating (2), due to the minimal level of effort required for maintenance. Mowing is a part of routine maintenance that allows increased visibility for a proper inspection. A higher rating is warranted if saplings or brush type vegetation grows where grass alone is intended, because removal of the brush requires more effort.

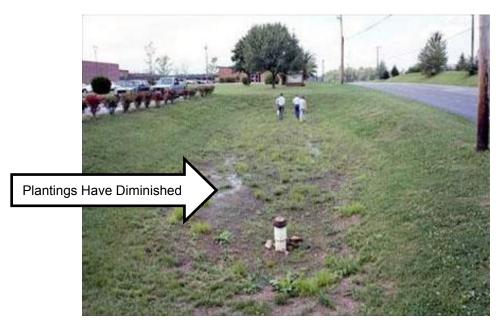
The vegetationhas diminished and the area has not been restabilized. This affects the pollutant removal capabilities of the facility. This is a minor rating (2) because the lack ofvegetation is affecting water quality but not raising the water level of the facility. If the poor vegetation was causing sedimentation or backwater a higher rating is warranted.

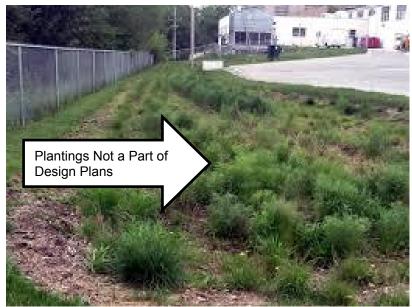
The plantings in this photo are different from those in the designed plans. Plantings that are not part of design can have a negative effect on the BMP's function. This warrants a minor rating (2), due to the level of effort required to remove the unwanted vegetation and reestablish turf cover.

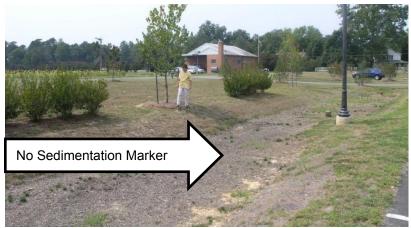
This facility does not have a sedimentation marker set at the finished elevation so that an inspector can determine the cleanout level. This warrants a minor rating (2), due to the minimal level of effort required for correct the problem. Consult the approved plans for proper elevations.

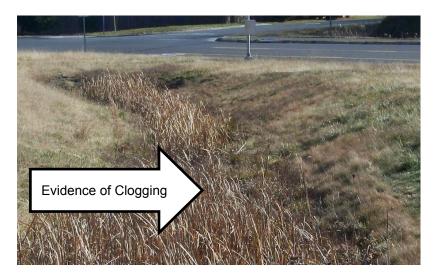
The wet plant species are indicators of clogging and water retention. This is a moderate rating (3) that is affecting the facility drainage. Care should be taken to ensure that the water levels are not affecting adjacent persons or property and proper infiltration rates and functionality of the facility are preserved.

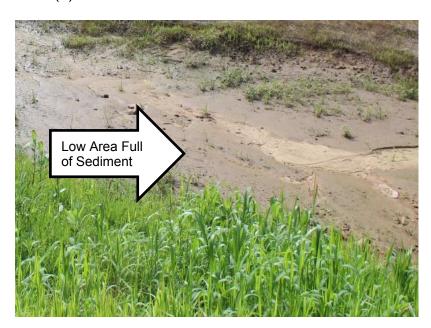
Sediment has built up and is effecting the storage volume and plant growth in this BMP. This warrants a minor rating (2) because the sediment is smothering the vegetation. A moderate rating (3) is warranted if the sediment impacts the storage volume and raises the water level or expands the footprint beyond property lines.

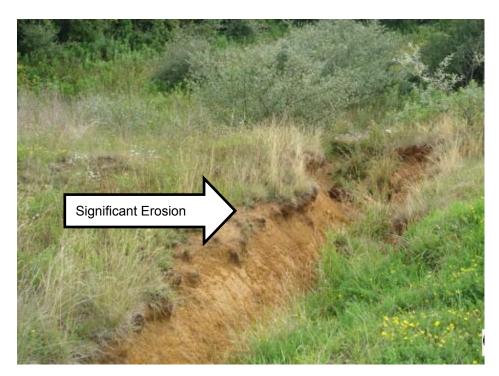
Inadequate stabilization and high flow, among other things, can cause the erosion in this picture. This warrants a moderate rating (3) due to the efforts requried to repair it. If this channel was in a residential area, it may warrant a higher rating.

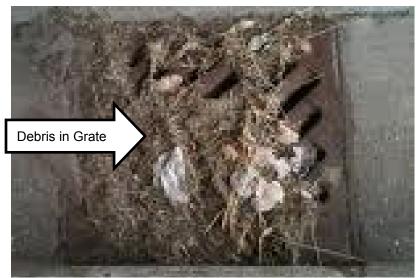
rating (3) because it is almost entirely clogged which can affect the water levels in the facility and potentially expand the footprint of the facility with backwater effects.

The grate has become clogged. This significantly impacts the operation of the facility. This is a moderate

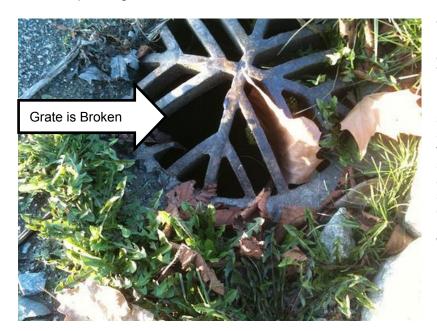
The grate on this facility has broken off. This is allowing debris to enter the facility. This is a minor rating (2) because the broken section is small and is not causing a significant performance or safety issue. If this grate were in a public area where safety was a concern, or if it allowed debris into the system large enough to create a significant blockage, a higher rating would be appropriate.

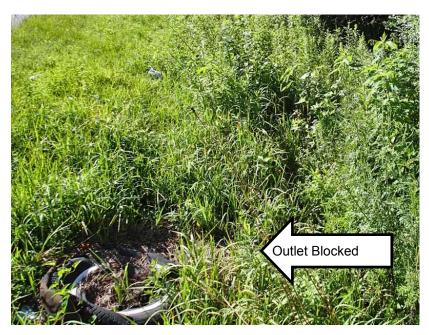
This grassed channel outlet has tires in it that prevent the water from draining properly. This is a minor rating (2) because this is a routine maintenance item. If the blockage is causing a backwater effect onto the roadway or personal property, a higher rating is warranted.

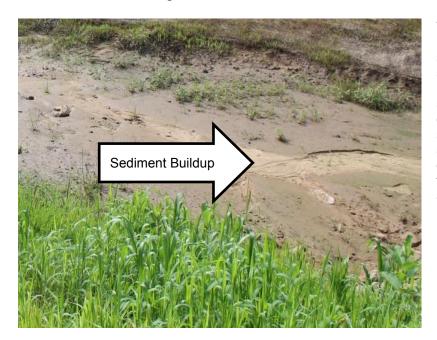
This warrants a moderate rating (3), since the BMP is still draining; however, the sediment needs to be removed and the area stabilized for the BMP to operate as designed. If the sediment is impacting the storage volume significantly or increasing the footprint of the facility, a higher rating is appropriate.

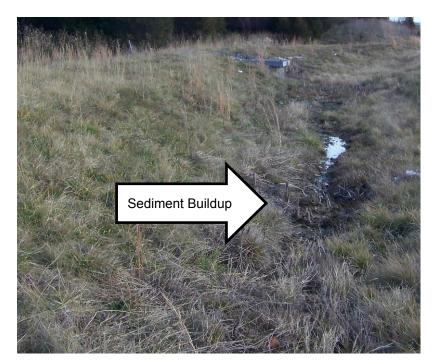
Sediment has accumulated and is affecting this BMP. This warrants a minor rating (2), because it is affecting the flow path to the BMP outlet but not affecting the storage volume or outflow from the facility. Care should be taken to ensure that the elevated water levels are not affecting adjacent persons or property, which would warrant a higher rating.

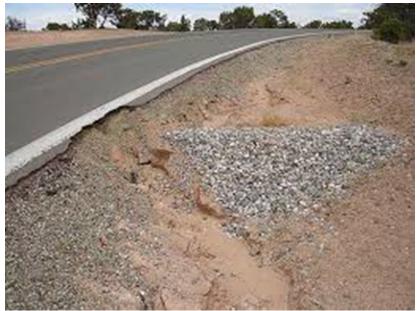
The flow in this picture is bypassing the check dam structure. Bypassing flows are typically evident by

erosion and scour around the structure or debris paths that circumvent the outlet/inlet. If drainage bypasses the structure unfiltered (i.e. flows outside of the inflow channel) but still delivers flow into the facility, it warrants a minor rating (2). If flow bypasses the control structure for large storm events, a moderate rating (3) is appropriate. If it is bypassing the structure on a regular basis, the structure has failed; rate it as major (4).

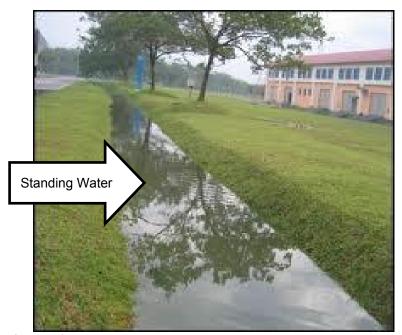
become clogged or blocked which is causing ponding of the water. This is a moderate rating (3) following a rain event because clogging can cause the water level to rise and pose a risk to persons and property. Note the facility's proximity to a public road and parking lot when considering the rating.

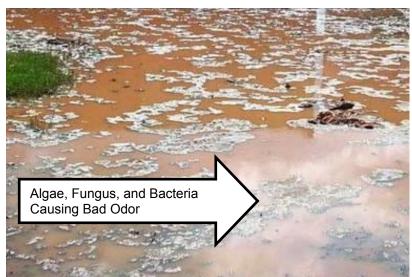
The bad odor in this facility can result from stagnant water indicative of a blockage, or from other sources. Typically there are other inspection deficiencies that are causing this problem. This warrants a minor rating (2). If public safety is a concern, the rating should be raised to a higher level.

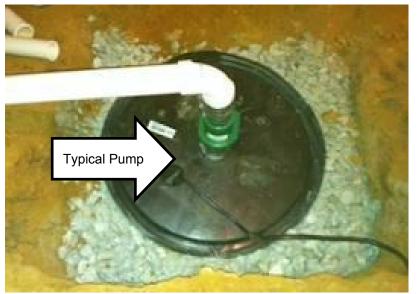
This photo is a picture of a pump; however, they come in many shapes and sizes but usually consist of a mechanical pump motor, outlet pipe, and a power source. Abnormal water levels are indication of pump failure.

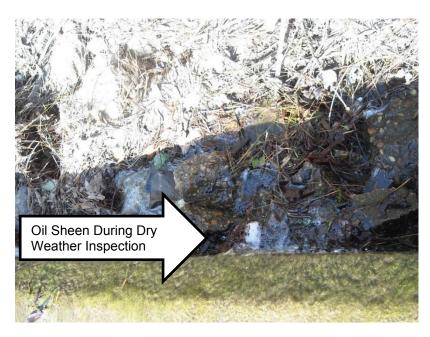
An oil sheen can be seen entering this facility during a dry weather inspection. This warrants a moderate rating (3), and the VDOT IDDE Manual should be referenced for further guidance on reporting and correcting the potential illicit discharge.

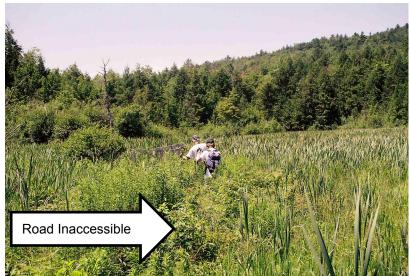
This facility has an inadequately maintained access road. There is significant minor growth that would impede equipment from entering the area for inspection or maintenance. This would indicate a minor rating (2) because the access road can be easily cleared due to the small brush. If heavier grade equipment was required to restore the access road, a higher level rating may be warranted.

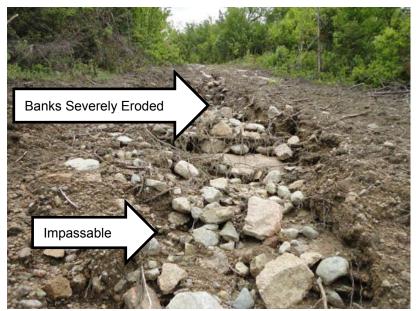
This access road has been inadequately maintained. There is significant erosion in the road area and on the banks. This erosion contributes to sediment deposition closer to the BMP. This warrants a moderate rating (3), because it requires restabilization for effective use but not complete reestablishment (e.g., of a new access road, cutting it through a forested area, requiring tree and stump removal).

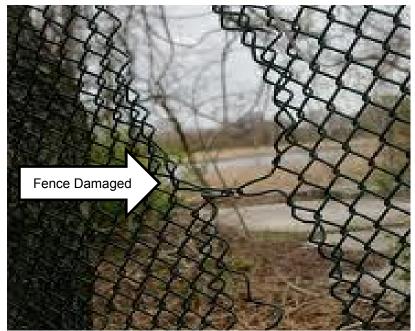
This fence is damaged and in need of repair to prevent the general public, and particularly children, access to the basin, perhaps risking their safety and leading to further damage of the BMP. This warrants a minor rating (2).

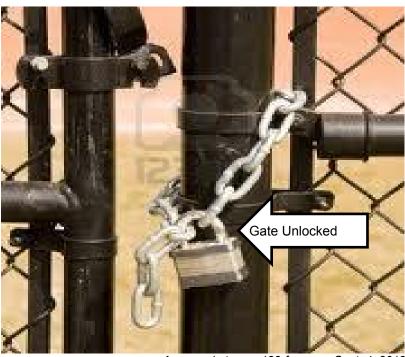
This gate has been left unlocked and can invite unauthorized personnel to access the facility. This warrants a minor rating (2).

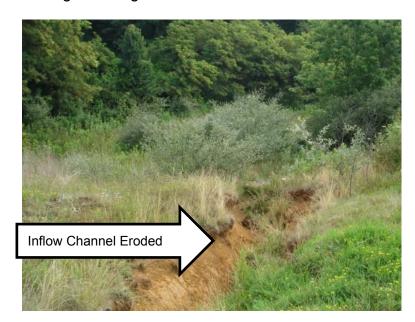
This inlet channel to the basin is severely eroded, possibly due to inadequate design, construction, or maintenance. This warrants a moderate (3) rating. The plans should be referenced to identify any design flaws and any possible causes of erosion.
