BMP INSPECTION MANUAL

Instructional Manual for BMP Inspection Program and Process

Maintenance Division 1401 E. Broad Street Richmond, Virginia 23219

June 2016

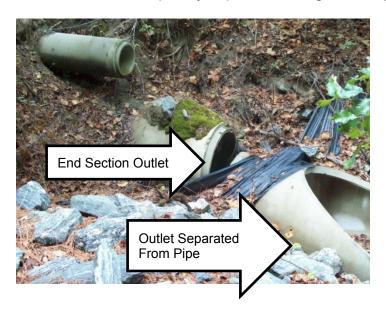
This end section has separated from the outlet pipe. This should be corrected to prevent any further deterioration at this junction and to ensure that the pipe system is operating as designed. This warrants a major rating (4) because the outlet structure has broken loose and is not operating as intended. This problem also potentially allows concentrated flows to be discharged into areas that may not be appropriately designed to handle such flows.

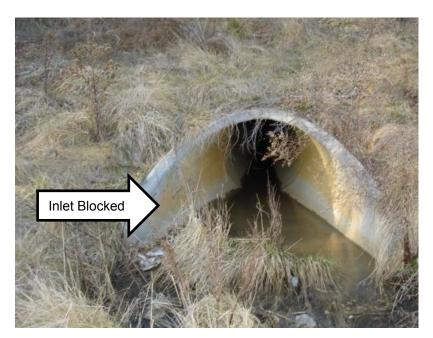
This inlet channel is partially blocked by vegetation. This impedes the flow of water to the basin and may allow water to backup into the pipe, affecting the pipe capacity and potentially creating a backwater issue. This warrants a minor (2) rating due to the minimal level of effort required to remove the blockage, which can be accomplished through routine maintenance.

Check, if applicable. This section evaluates any types of blockages to the basin inflow systems. Such blockages can cause stormwater to back up outside of the basin area and potentially impact surrounding areas. This warrants a minor rating unless the backwater affects private property or public infrastructure, which justifies a higher rating.

If blockages at inlets to the basin are not impacting adjacent properties or creating new flow paths, a minor rating (2) is appropriate. Cleaning blockages to inlets is a part of routine maintenance. If the blockages are backing up water on adjacent property or creating new flow paths, a moderate rating (4) is justified. Note, based on the judgment of the inspector, if the blockage has the potential to damage private property, the rating may be increased based on the potential liability. This should be addressed in the notes section under this component heading.

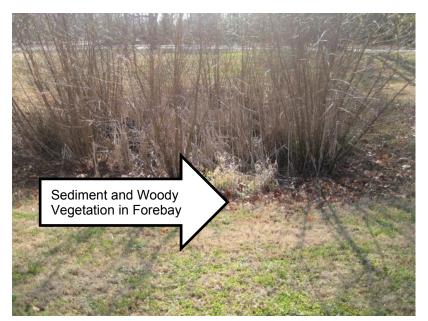
This forebay is filled with a significant amount of sediment and woody vegetation, affecting the storage volume. This warrants a moderate rating (3) due to the substantial growth in the forebay that is affecting its capacity.

"Silt, sediment, or vegetation has filled in significant portions of sediment forebay" Check, if applicable. If there are significant amounts of sediment or growth in the forebay, it cannot store and filter the volume of flow it was designed for and therefore cannot fully function. Forebays generally provide 10% of the required storage volume for the basin. Forebays require more frequent maintenance than the associated basin because they act as a preliminary sediment trapping measure prior to flows entering the basin itself. Forebay maintenance may occur more frequently than the basin maintenance, but it is typically less intensive to perform. Routine maintenance should include cleaning out the forebay and therefore would result in a minor rating, unless the volume of sediment captured has resulted in flow blockages, deterioration of structures, or significant storage volume impacts, warranting a higher rating. Locating the source of erosion and sediment from upstream is critical to maximizing the time between such cleanouts, and the upstream sources should be checked to determine if they are associated with an illicit discharge. If so, refer to the illicit discharge item discussed below under "Impoundment Area."

In the forebay, removal of silt and debris and thinning of vegetation (only if it impacts the storage volume or prevents positive drainage) is a part of routine maintenance and warrants a minor rating (2). Forebays typically contain 10%-15% of the required storage volume of the entire basin facility; therefore, if the conditions slightly impact the function of the facility, a moderate rating (3) is appropriate. If there is no trapping capacity or storage volume capacity left in the forebay, give it a major rating (4).

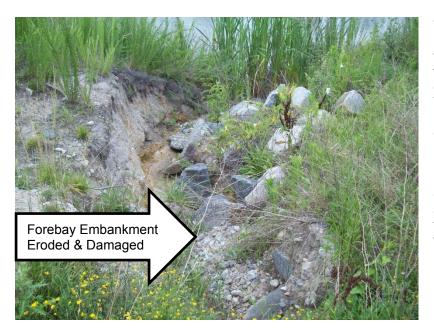
The forebay embankment has significant erosion along the outer edges, causing flow to bypass the filtering effect of the stone berm. This could be due to inadequate design, construction or maintenance. It is helpful to review the original plans to identify design or construction flaws (e.g., appropriate dimensions of the forebay weir, etc.). This warrants a moderate rating (3) due to the level of effort needed to accomplish proper maintenance.

Check, if applicable. This item describes deterioration of the area where the drainage leaves the forebay and spills over into the basin. This embankment, usually riprap, acts like a weir to filter the water flowing into basin area and prevent as much sediment as possible from entering the main basin. If the majority of the riprap is present and needs only minor maintenance (e.g., reshaping or adding a small amount of hand placed rock, etc.), such work can be covered under routine maintenance (minor rating of 2). More severe conditions warrant a moderate to major rating (3-4) for this component heading. For example, if the embankment or riprap berm is breached and is thus causing significant impacts to the basin and outlet function, this would warrant a major rating (4).

If the forebay embankment has deteriorated, damage to the facility is occurring. The forebay is a first flush trapping measure for sediment and debris entering the basin. It also slows the flow of water into the main facility. Erosion of the embankment/spillway is indicative of higher than expected velocities and / or larger than predicted flows. Additionally, forebay embankment/spillway may be poorly

constructed (e.g., the riprap may not be large enough. A minor rating (2) could be remedied by routine maintenance, such as reshaping a portion of the riprap weir or repairing isolated erosion. If more effort or large construction equipment is required for the repair, a moderate rating (3) should be given. If the embankment has been breached or is otherwise not functioning properly, a major rating (4) is warranted.

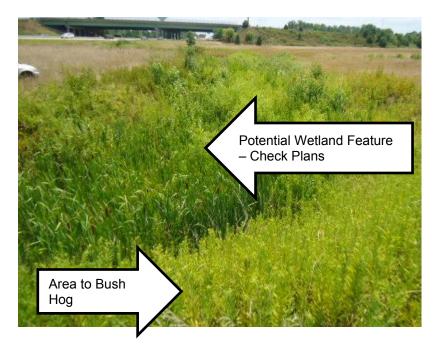
This basin, overgrown with natural vegetation, warrants a minor rating (2), since it can be bush-hogged and does not require construction equipment for maintenance. Mowing should be performed twice a year as routine maintenance, which also increases visibility for detailed inspections.

Check, if applicable. This item describes extensive vegetative growth on the dam that can be removed with a lawnmower or bush hog. This vegetation prevents visual observation of the dam surfaces for critical issues. This warrants a minor rating, and it can be addressed through routine maintenance.

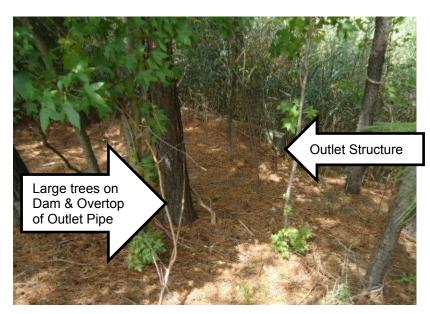
This dam has large trees on the face, top and back of the embankment, making it prone to seepage and potential failure. Additionally, some of the larger trees are directly above the principal spillway pipe and can cause damage to the pipe. Removing the trees and stumps will require structural backfill. This warrants a major rating (4) based on the location of the trees and level of effort required for necessary repairs and maintenance.

Check, if applicable. Trees or brush with woody stalks should not be allowed to grow on the dam. The root systems of these trees create a potential seepage path within and through the dam. Roots can also die off and create even larger void spaces within the dam that can go unnoticed until significant problems arise. The rating should be based on the size, density and location of the growth. Heavy growth around and above outlet structures, the conduit through the dam and outlet itself should have a higher rating than would the presence of trees high on the dam (well above the water levels) or on the fringes of the embankment. Also consider in the rating the necessity of removing stumps, their location and size, and the need to subsequently backfill with appropriate compacted material (i.e. clay type material with low permeability and no sand).

If "Trees or woody vegetation growing on embankment "is checked and there are saplings on the embankment, a minor rating (2) is appropriate, since this can be addressed through routine maintenance. If there are larger trees over/near the spillways, a major (4) rating is warranted. This rating may also be upgraded based on the amount work involved and the necessity of using construction equipment to remove the woody growth. Note that the Virginia Stormwater Management Handbook recommends removal of trees within 25 feet beyond the toe of the dam and abutments, but property lines and wetland impacts may restrict access to this entire area.

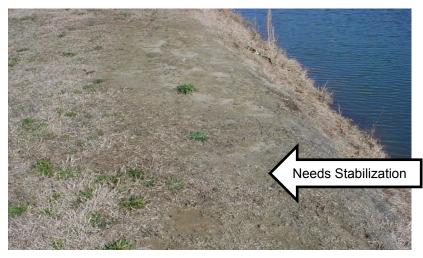
This dam is not stabilized adequately with vegetation, which leads to erosion and loss of dam fill material. This warrants a minor rating (2). If resulting erosion is contributing to sedimentation in the basin, then it will be addressed in another inspection topic as well. Restabilization seeding and mulching can be accomplished through routine maintenance.

Check, if applicable. The surface of all dam slopes and earthen components should be stabilized to prevent erosion and subsequent siltation in the facility or receiving channel. Erosion of the dam is covered in the next topic. This warrants a minor rating, since remedies can be accomplished through routine maintenance.

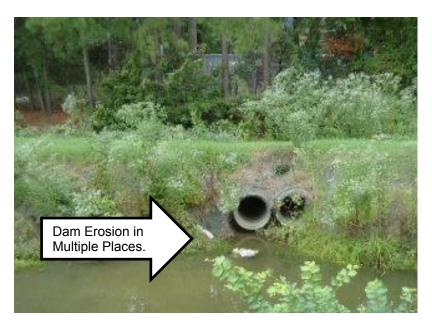
Erosion on this dam is causing structural instability. The dam has erosion in multiple locations, including above the principal spillway pipe, which can be indicative of other issues (e.g., seepage, etc.). These repairs will require structural fill. This warrants a moderate to major rating (3-4), depending on the amount of the pipe that is exposed and its stability.

Check, if applicable. Erosion is indicated by bare areas where soil is washing off the face, top or back of dam. Erosion can weaken the dam through loss of material, cause a sediment buildup in the basin, and/or be indicative of other problems, including within the dam structure itself. Erosion can result from inadequate stabilization, which is also a separate inspection topic under this component heading. When evaluating the embankment, it is important to know that the compaction and cohesion of the soils is what creates the water tight embankment to resist the hydraulic forces.

If the "erosion on the dam" is shallow on the surface and the result of inadequate stabilization, a minor rating (2) is appropriate and routine maintenance is adequate

to accomplish needed repairs. If the erosion is deeper, the cause should be investigated and a moderate level rating (3) should be given. Be aware that repairs for such erosion require compacted fill with the same soil characteristics as the material from which the dam was constructed. If the erosion is around or above the spillway structure, it may be indicative of another issue as well (e.g., seepage through the dam, etc.). A major rating (4) should be given for that, with further investigation to determine the cause.

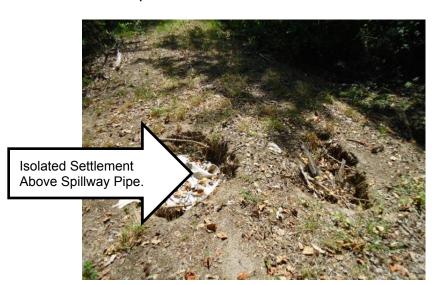
Isolated areas of settlement above the principal spillway pipe indicate issues internal to the dam itself (i.e., material is being lost). Round sunken areas in parallel are usually indicative of holes on the pipe (e.g., lift holes in RCP pipe not being patched) or joint separation. This warrants a major rating (4).

Check this box if there are changes in the vertical surface of the dam (sunken areas) as a whole or in an isolated location. This can be evidence of soils further consolidating from their own weight over time, or loosing material somewhere within the dam (e.g., through a loose pipe joint). Determining the cause of the settlement is critical and includes evaluating other topics listed in the inspection form, which could increase the rating as well as affect the ratings of other inspection items.

If observed "settlement" is isolated and small, not located below the elevation of the emergency spillway, and not the result of additional problems, the rating should be minor (2). If the settlement is broader/deeper and in more than one location, a moderate rating (3) is appropriate. Settlement observed above or around spillway structures requires additional investigation to determine the cause and warrants a major rating (4).

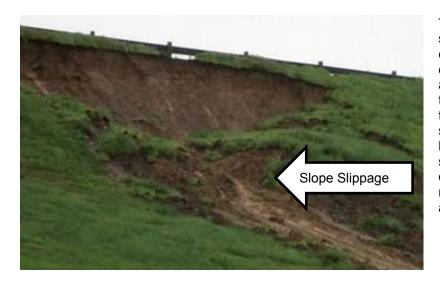
This picture shows a typical slope slippage condition with clearly defined areas of exposed soil and stabilized areas adjacent to them. If the slippage is on the face of the embankment near the spillway, the rating should be major (4); however, if the slippage is located on the outer sections of dam, a moderate rating (3) is appropriate.

Check this box if there are sections of dam surface that have slid downward leaving exposed soil. This is more common at the abutments where the natural ground meets the compacted fill material at the ends of the dam, which is less problematic. If present on the central portion of the dam, especially above the control structure and barrel of the discharge pipe, slipping and sloughed material is indicative of poor compaction or other problems within the dam below that area.

The rating for slope slippage is based on the location, area, and amount of soil moved/lost. Shallow areas of sloughing/slippage on the fringes of the embankment warrant a minor rating (2), since it can be repaired through routine maintenance. Slippage on the dam embankment warrants a moderate rating (3). Slippage and sloughing around the spillway can be indicative of other issues and warrants a higher major rating (4). To ensure a long-lasting repair, the cause of the slippage should be determined.

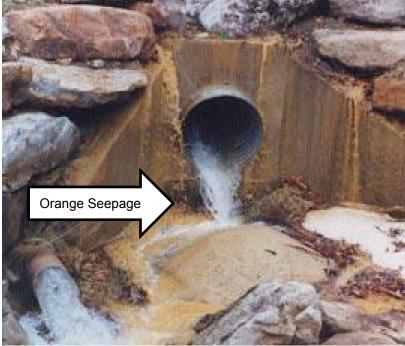
Note seepage around the riprap above the endwall. The orange color and sediment deposits below it indicate loss of internal dam material. If observed during a rain event this would warrant a major rating (4), indicating a potential for imminent failure. However, if it were observed to persist during dry weather, it should be considered a failure (5) because it is draining the normal pool, creating an unregulated flow.

Check this box if there is evidence of water seeping through the dam. Seepage is evident on the back of the dam as water flowing out of the dam surface, or as indicated by an area of the dam surface that always remains wet (which may warrant a minor rating but also continued observation). Seepage occurs below

the basin water level on the back of dam, and can be evident up to 10'-25' beyond the toe of the dam. This is a very critical condition that could lead to a failure of the structure, or it could be due to something as simple as a blocked toe drain. Note the color and estimated flow rate for future comparison. Clear or clean water seepage is less problematic than colored water, which could indicate transport of structural soil from within the dam. If the flow is active and clear, it warrants a moderate rating (3) and further monitoring and/or investigation. Occasionally the seep is a result of a spring in the area; if it remains clear with a stable flow rate and without erosion, it is probably not significantly impacting the dam. If the flow is cloudy or colored (particularly if it is orange like clay), and causing erosion of material on the dam surface, this warrants a higher major or (potentially) failure rating (4-5) and further investigation.

If "Downstream seepage noted" is checked, the rating can vary from minor (2), in the case of a damp area on the downstream impoundment, to major (4), in the case of free flowing cloudy or colored water that can indicate soil is being flushed from within the dam structure. Dam areas with small or intermittent flows of clear water are less problematic and should be given a moderate rating (3), but they should continue to be monitored. If the seepage is causing erosion, slope slippage or any loss of dam material, a major rating (4) should be given.

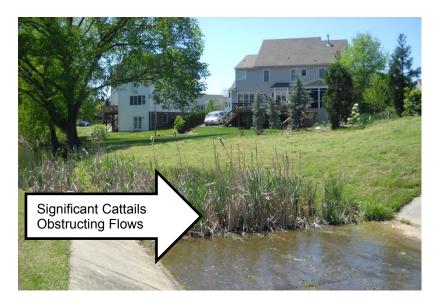
There is vegetative growth impeding flow across the emergency spillway. This could possibly cause overtopping of the dam and adjacent flooding under certain conditions. This warrants a moderate rating (3), due to the level of effort required to accomplish proper maintenance and the potential damage to persons or property in the residential area.

Check this box if there are any blockages that slow or obstruct flow in the emergency spillway channel, including at the entrance or exit. Cleaning out the channel is a part of routine maintenance and warrants a minor rating (2). If the blockage is significantly impacting the function of the channel it warrants a moderate rating (3).

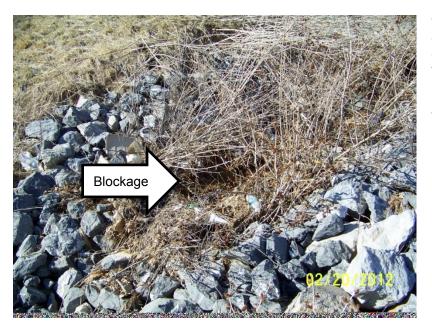
The brush observed in this emergency spillway will continue to impede flow if the spillway is not maintained. This warrants a minor rating (2), because of the minimal level of effort required for maintenance. Removal of woody brush is a part of routine maintenance.

Check this box if there are trees or brush present within the emergency spillway, which could damage the channel, slow flows out of the basin, and raise the water level. Clearing such vegetation is a part of routine maintenance and unless the severity qualifies as "Non-Operational," as described above, it warrants a minor rating (2).

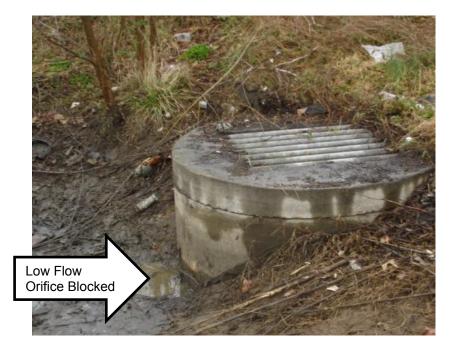
This outlet structure has a large amount of dirt and debris that is preventing the water from draining properly. This is a major rating (4) because this could possibly produce high water levels that could affect person and property during high storm events. High water levels are evident from the debris lines well above the top of riser in the background.

Check this box if any outlet openings on the downstream side of the dam are blocked, and specify which one in the Notes section if more than one opening is present. The outlet structure is a critical component of basin functionality, since a blockage of the outlet can back up water and raise the water level in the

basin, potentially causing overtopping of the dam. It becomes more critical if more than one opening to the system is blocked, which warrants a higher rating than a minor or moderate, based on severity of the blockage.

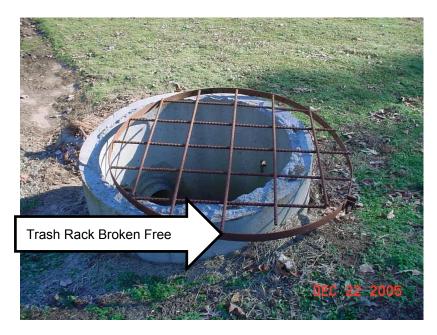
The trash rack on this structure has broken free, posing a potential safety hazard to the public and allowing trash to enter the facility and clog the outflow pipe. This warrants a moderate rating (3) because of the level of effort necessary to make the repairs. The rating should be increased if the facility is in close proximity to residences, parks or schools with public access.

Trash racks prevent debris and trash from entering the outlet structure and causing blockages; however, if they are damaged or missing, allowing the outlet to become extremely blocked and restricting flow, the water level in the basin could rise above the design elevation.

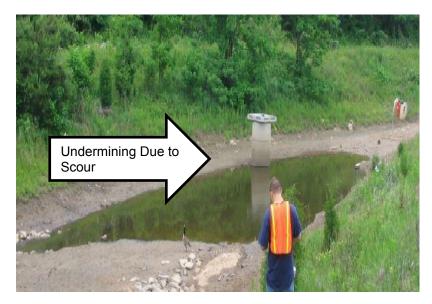
The riser is sitting slightly off kilter, which may be an indicator of undermining at the base. There appears to be a slight gap between the base of the riser and bottom grade of the basin. This warrants a minor rating (2) since it is still connected more than 50% of the circumference. If it is not corrected in a timely manner, the riser could fully separate and stormwater would leave the facility uncontrolled and untreated which would warrant a failure rating (5) e. Failure of the structure is addressed below.

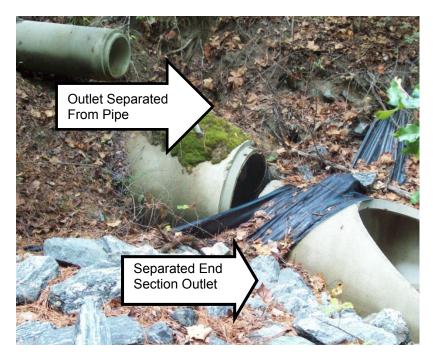
The outlet pipe has separated from the riser structure. This warrants a moderate rating (3) because the separation could cause water to flow out of the separated portion causing surrounding damage. This is especially true during large storm events, which could result in the leaching of dam material. If evidence of piping and material loss are present, a higher rating is warranted.

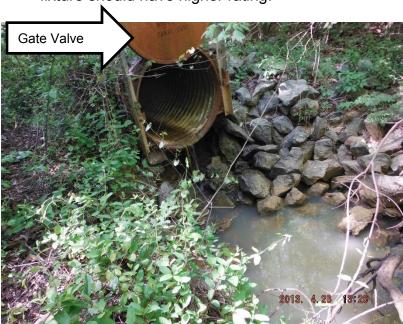
A typical gate valve is shown. Valves should be regularly maintained and periodically exercised to ensure functionality. The rating depends on the level of effort to operate the valve and its purpose and location.

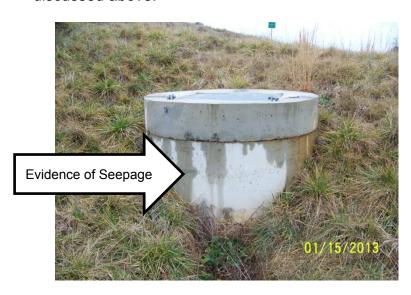
There is evidence of seepage from the joint between the grated top and the riser pipe. This warrants a moderate rating (3). A higher rating is warranted if there are more serious leaks, causing the area around the riser to become saturated during storm events.

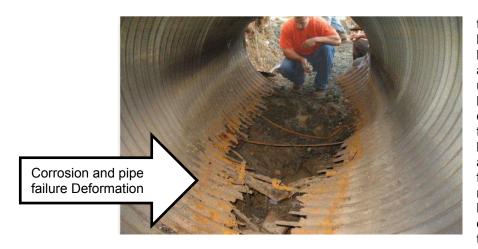
the CMP principal spillway has corroded through the bottom of the pipe. This allows drainage to undermine the pipe and flow beneath the structure eroding away the subbase of the PSP.Also, draimage leaves the facility untreated and uncontrolled. This is a failure rating (5). Immediate remediation efforts should be taken to prevent further damage and a full breech of the dam.

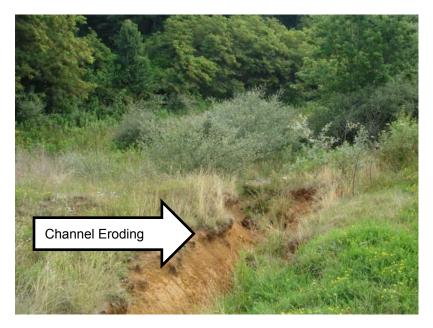
The outlet channel to this basin is severely eroded, possibly due to inadequate design, improper outlet protection, improper construction, or the lack of maintenance. This warrants a moderate rating (3). The plans should be referenced to identify any design flaws and any other possible reasons for the erosion. The rating should be increased if there is potential for damage to persons, downstream property, or environmentally sensitive areas.

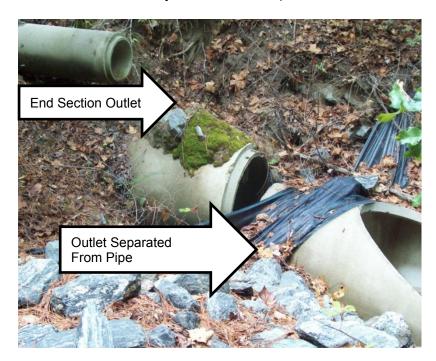
This end section has separated from the outlet pipe. This must be corrected to prevent any further deterioration of the outlet structure and, potentially, the dam, and to ensure that the pipe system is operating as designed. This warrants a major rating (4) because the outlet structure has broken loose and is not operating as intended. The configuration of the broken pipes also potentially conveys concentrated flows into areas that are not appropriately designed to handle such flows.

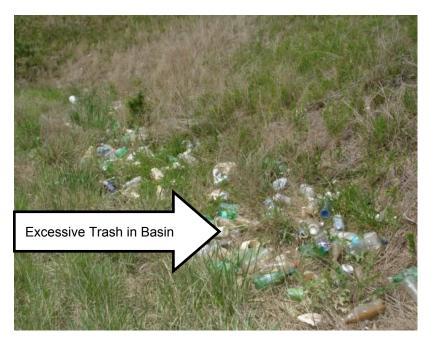
Excessive trash and debris has accumulated in a channel that is part of the basin due to inadequate maintenance. This warrants a minor rating (2) due to the minimal level of effort required to remove the trash. If the trash were blocking an outflow structure or required more effort to remove it, a higher rating would be warranted.

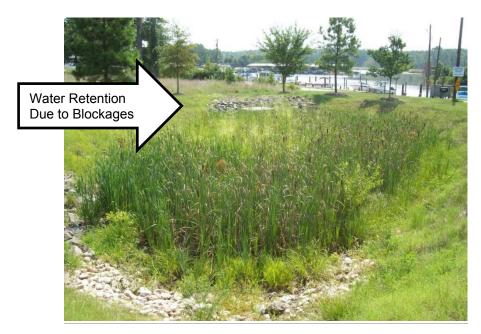
Cattails are a sign that water is being held in this basin. This warrants a minor rating (2) because the ponding is limited to an isolated area and can easily be corrected. If the ponding occurred over the whole facility and required more effort for maintenance, a higher rating would be appropriate.

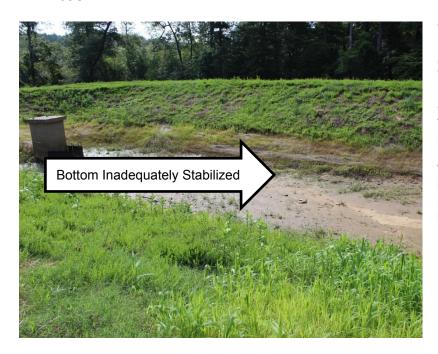
The bottom of this basin was inadequately stabilized during a recent renovation. This warrants a minor rating (2) due to the minimal level of effort required to correct this. If there is also sedimentation present, a higher rating may be warranted due to the level of effort required to remove the sediment and permanently stabilize the area.

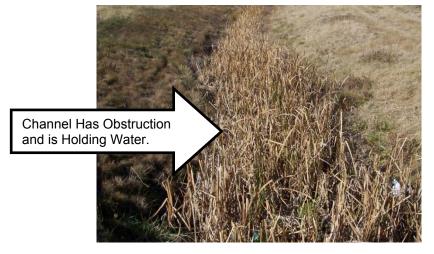
The ditch is blocked, which is causing permanent water accumulation and cattail growth. This warrants a minor rating (2), because the facility appears to still be functional and there is no evidence of water backing up beyond the facility footprint. If backwater increased the facility footprint, especially if the backwater crossed property lines, a higher rating would be warranted.

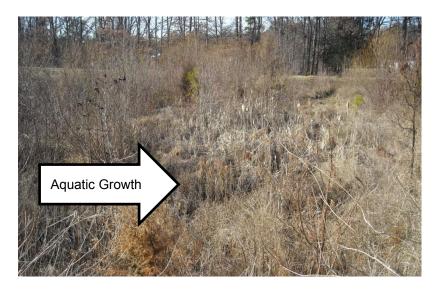
The aquatic growth in the above photo impacts the basin storage volume. Having the proper storage volume available is critical for proper operation of the facility. This warrants a moderate rating (3) because the facility still functions and there appears to be no flooding. A higher rating is warranted if additional structures are being affected, there is evidence of dam overtopping, or more extensive effort is required to remove the overgrowth (e.g., trees with stumps).

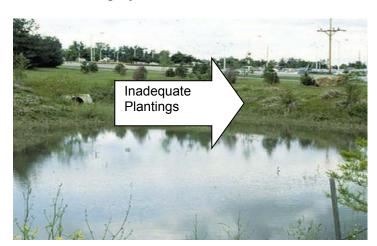
The brush type vegetation growing in this facility is not representative of plantings listed in the design specification or the basin plans. The planting plan is an intergral part of achieving target pollutant removal; therefore, inappropriate vegetation should be removed. This warrants a minor rating (2) due to the level of effort required to remove the undesirable vegetation and the fact that it is stabilized. If the removal effort was more intensive and required extensive replantings, then a higher rating would be warranted.

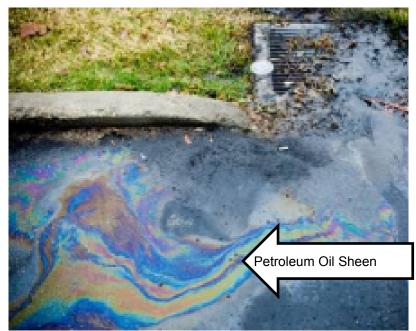
This oil sheen is evident during a dry weather inspection. This warrants a moderate rating (3) and the VDOT IDDE Manual should be referenced for further guidance on reporting and correcting the potential illicit discharge.

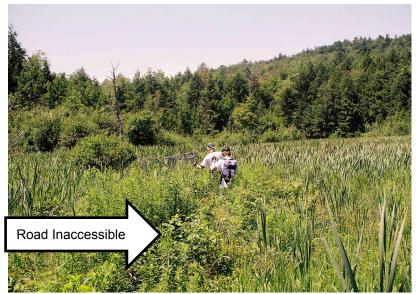
This facility has an inadequately maintained access road. There is significant minor growth that would impede equipment from entering the area for inspection or maintenance. This would indicate a minor rating (2) because the access road can be easily cleared due to the small brush. If heavier grade equipment was required to restore the access road, a higher level rating may be warranted.

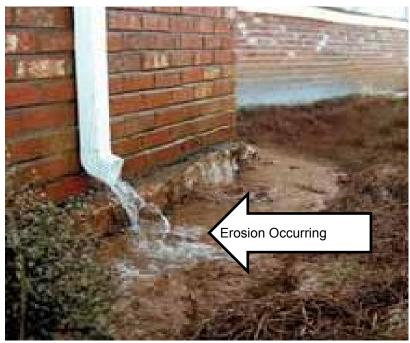
High discharge velocities from this downspout and inadequate outlet protection are causing severe erosion. This warrants a moderate rating (3) because of its proximity to the building foundation.

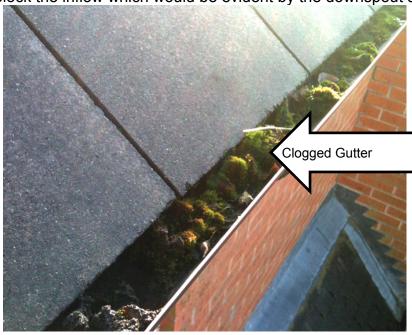
Gutter is blocked to the point where rainwater harvesting is not possible. This is a minor rating (2) due to the minor effort required for repairs. Removal of blockages should be part of routine maintenance.

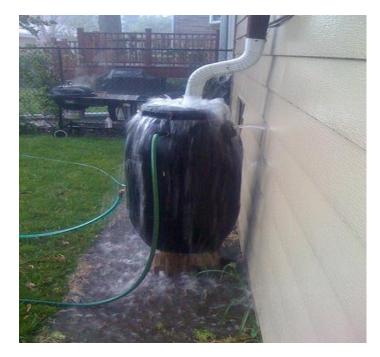
The rain barrell cistern is being overwhelmed by the rain event. However, outlets should be checked for blockages to ensure that is not the source of overflow. This is a minor rating (2) item. If the overflow causes erosion or floods structures a higher rating is warranted.

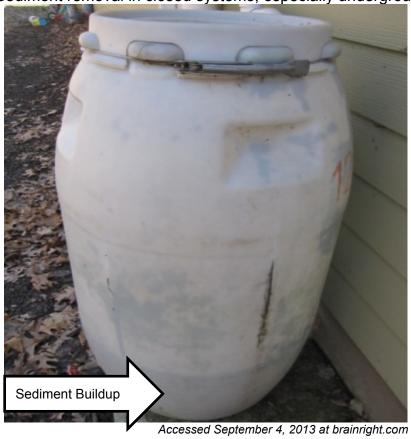
Sediment has built up in this rain barrel due to inadequate sediment filtration of rainwater before it enters the barrel. This warrants a minor rating (2) due to the minimal level of effort need to achieve the repair, which can be accomplished through routine maintenance.

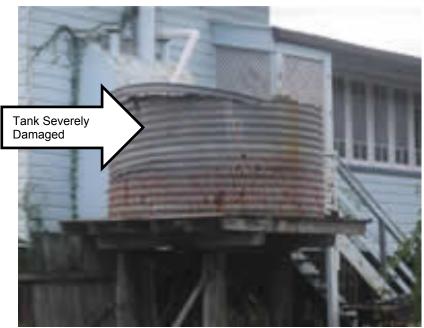
This rainwater cistern has become severely damaged (rusting) due to inadequate coating and exposure to the elements. It would rate as a failure (5) if water was freely flowing from the cistern or if it was not watertight.

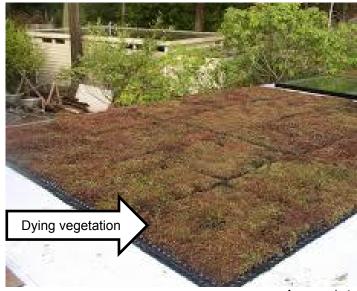
Vegetation is the key design component for a vegetated roof. Ensuring the plantings are alive and functioning ensures meeting the design critera for the facility. Here part of the roof is well vegatated and part of it is dead and not providing any pollutant removal. This warrants a minor rating (2) and if more plants were dead, the rating would be higher.

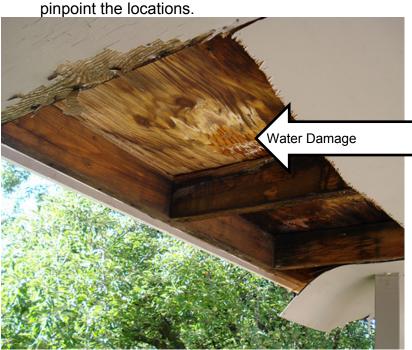
A leak in the membrane is evident from the water damage to the roof structure directly below the leak location. This warrants a failure rating (5) due to the resulting property damage and the potential for greater structural impacts and the associated risk to human safety.
