VDOT

Preliminary Bat Inventory Guidelines for Bridges and Buildings

VDOT Environmental Division

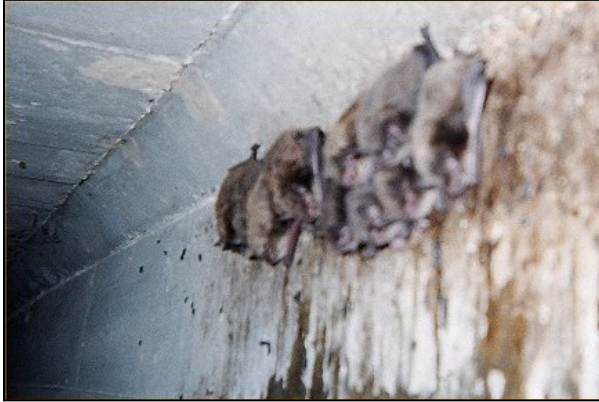
Photo 1: Bats hanging from cracks along support beams***

Cracks in the concrete are used by bats as a foothold in roosting (Photo 1, Appendix B). In addition, some bats may be hidden from sight in wider cracks in the concrete and behind deteriorating concrete sections in the ceiling or walls. Look for cracking along support beams and inner walls especially below a fillet (a concrete filling between ceiling and vertical beam). During inspection, sounds may be heard coming from behind such cracks and/or expansion joints.

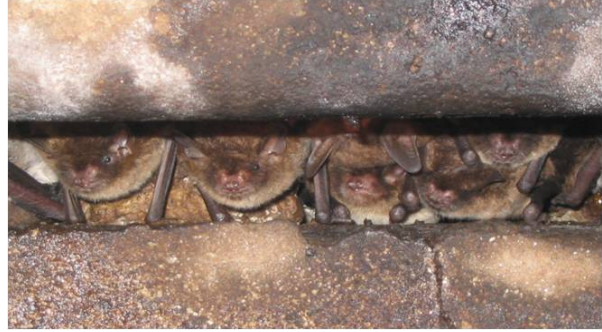
Photo 2: Visible bats within an expansion joint*

Expansion joints can provide protected cover for bats (Photos 2 and 3), but do not always provide habitat, depending upon whether they are obstructed by road debris or other blockages to use. If possible during inspection, individuals should look into expansion joints or in other cracks with a flashlight. If joints are used by bats, often there will be guano under the joints, but not always, since the joint may be located over water.

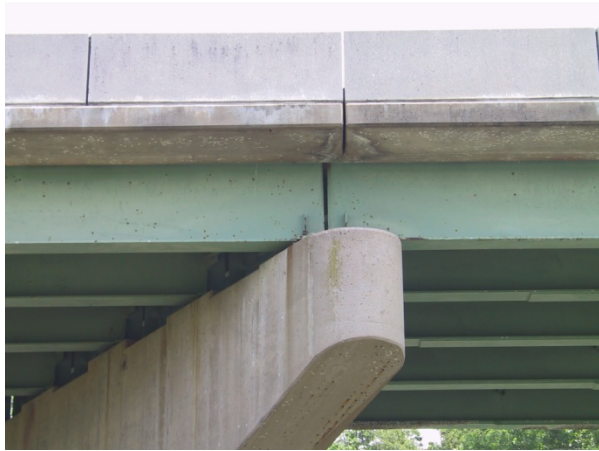
Photo 3: Example of open concrete joint used by bats**

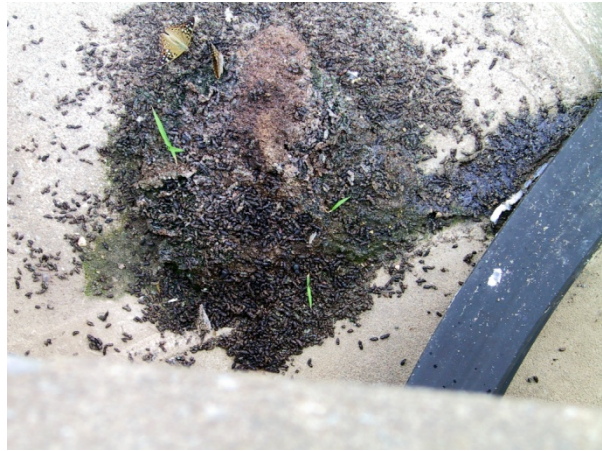
Photo 4: Guano deposits visible from bridge deck, on top of pier**

Bat droppings are small (mouse-like in appearance but less regular), brown or black pellets (Photos 4-6). Older droppings may be gray in color. These droppings will accumulate on the ground, floor of a covered bridge or on structural components below where bats roost. Droppings may also adhere to support beams and walls below roosts.

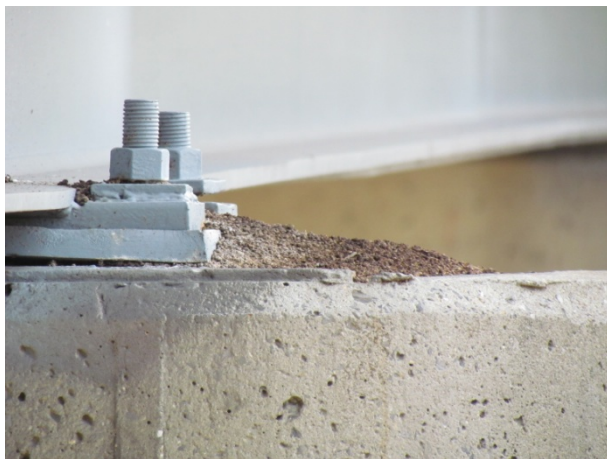
Photo 5: Guano deposit on pier, obscuring structural features

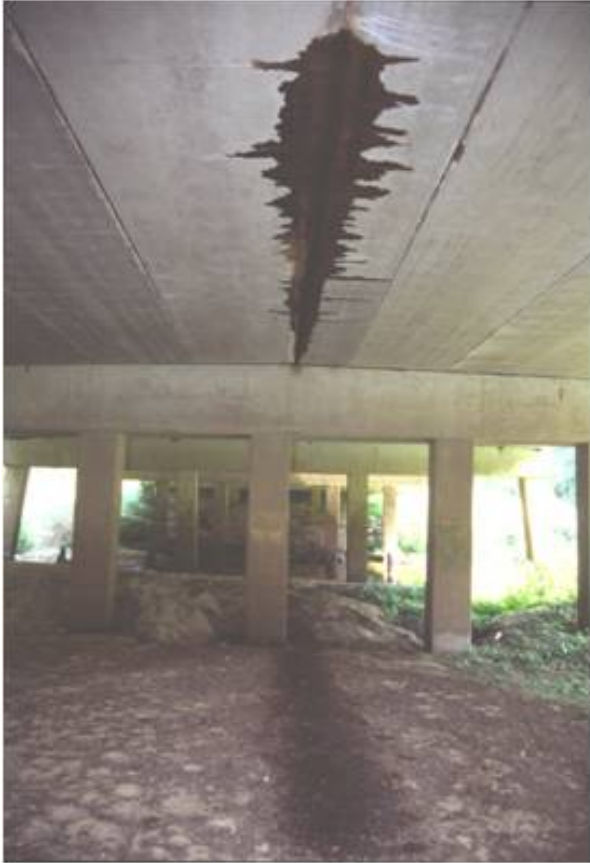
Photo 6: Staining along longitudinal joint. Note guano deposits on ground*

Stains may appear wet and are usually found in dark places. Look for four to six inch wide dark stains located on concrete support beams and walls immediately below the ceiling of the bridge, and beneath joints (Photos 6-9). Ceilings, walls, and joists may be stained in buildings. Stains may have a musty odor, but care should be used with this, as other sources may be the cause of any odors (mildew, pet odor, etc.).

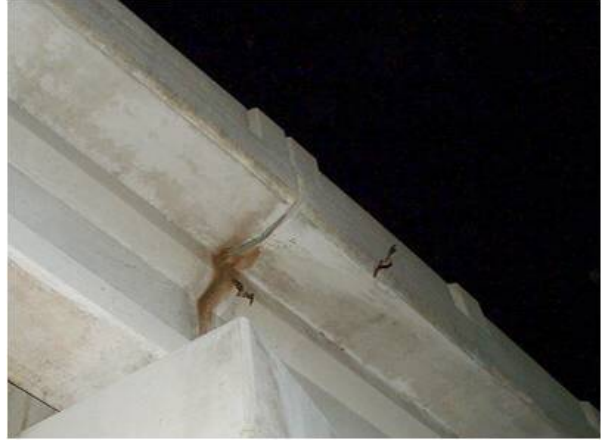
Photo 7: Staining on underside of expansion joint from bat use. Note bats in vicinity*

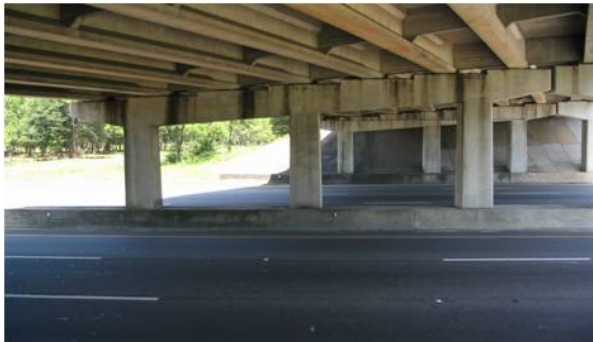
Photo 8: Staining on sides of pier caps*

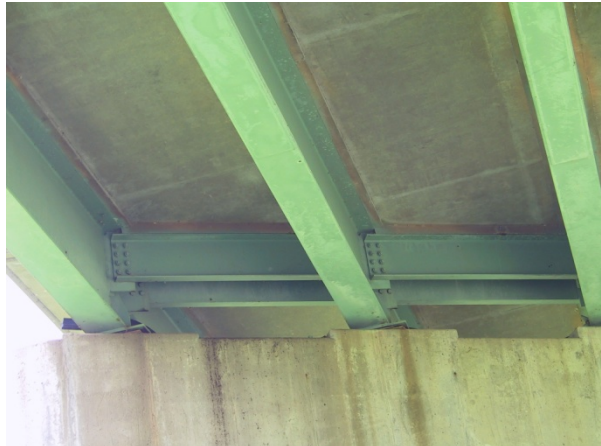
Photo 9: Guano staining on side of pier**

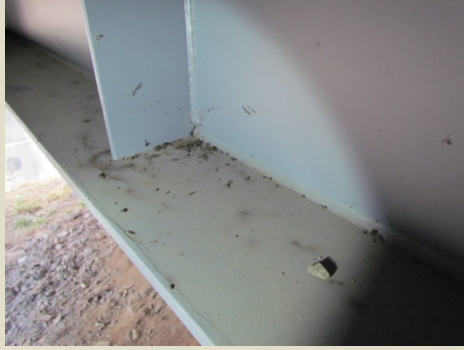
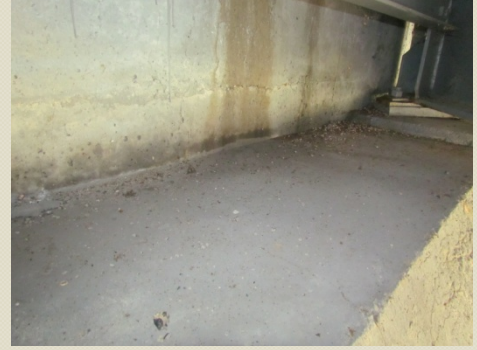
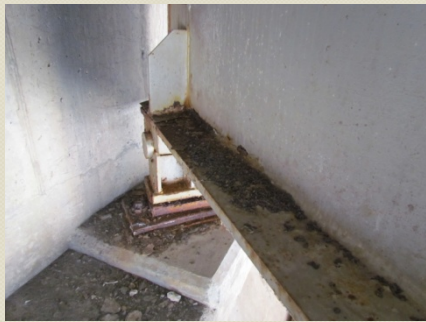
Small deposits – scattered guano on structures, but does not cover continuous areas.

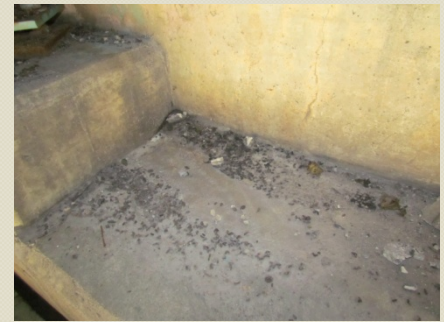
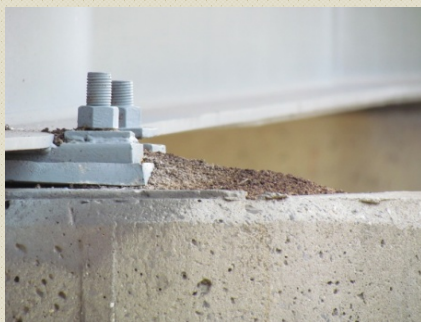
Moderate deposits – guano covers more or less continuous areas, but does not accumulate to the point of obscuring features.

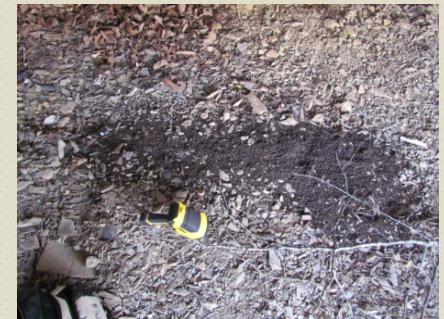
Large deposits – guano covers large areas, able to obscure some features of the bridge substructure.
